Stockbridge Bowl Watershed Survey

Conducted by the BRPC, SBA and Town of Stockbridge

June 2012

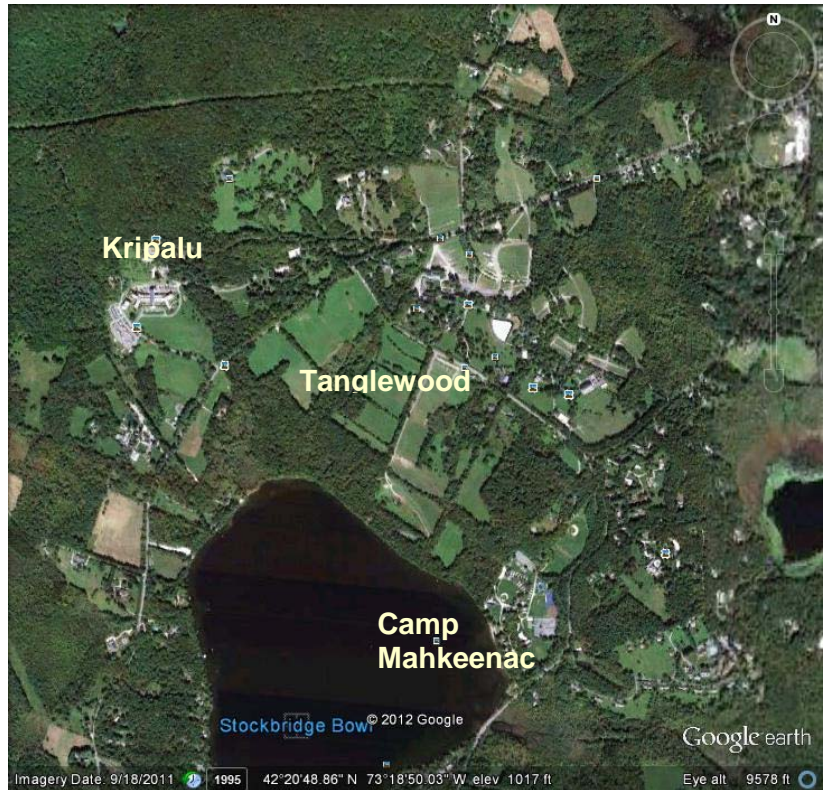
- a) This shoreline contains fluvial deposits at the mouths of Mahican Brook, Shadow Brook and the three unnamed tributaries. Although there is some development in these sub-basins, the streams flow through largely forested areas. Steep slopes and deeply carved channels characterize these streams. The in-lake deposits consist largely of

sand and gravel, with little muck or organic material. Lake residents have stated that the sediment input has increased exponentially in the past five years or so.

- b) Erosion from the area at and near Camp Mahkeenac's beach.
- c) Imported limestone gravel was observed in the lower reaches of the Bullard Woods tributary. It appears that this was washed down from a stream crossing culvert on Bullards Woods. Flood waters overwhelmed the culvert and eroded backfill around the culvert. Replacing the undersized culvert with a new crossing that spans the stream should be considered.

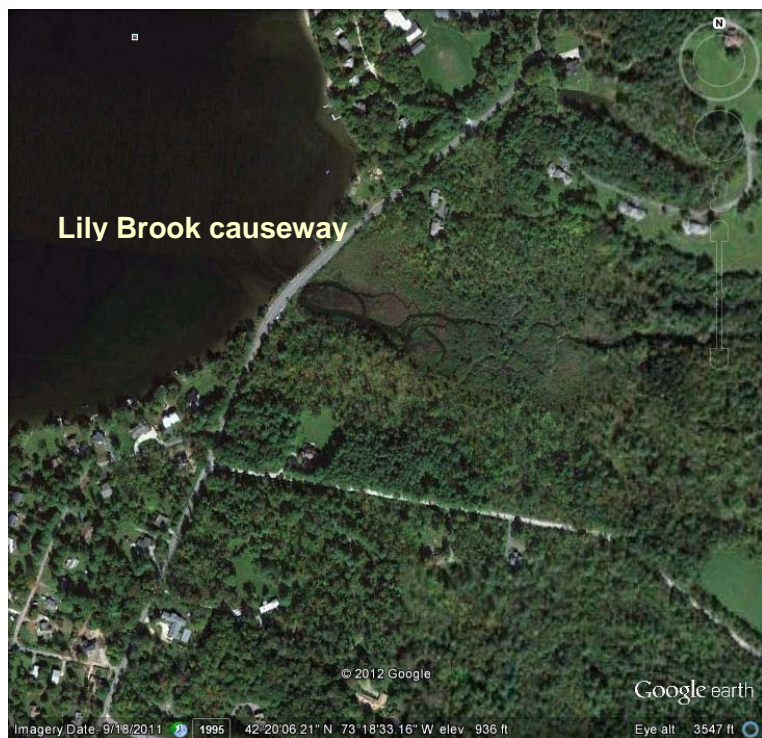
- a) The Lily Brook inlet upstream of the causeway is exponentially filling in with sediment.
- b) The Lily Brook inlet on the lake side of the causeway is severely impacted by sediment and resultant invasive aquatic plant growth.

- c) The gravel parking areas drain into the lake from both sides of the road.
- d) Road sand and salt applied to Mahkeenac Road during winter drain into the lake from both sides of the road with no treatment.

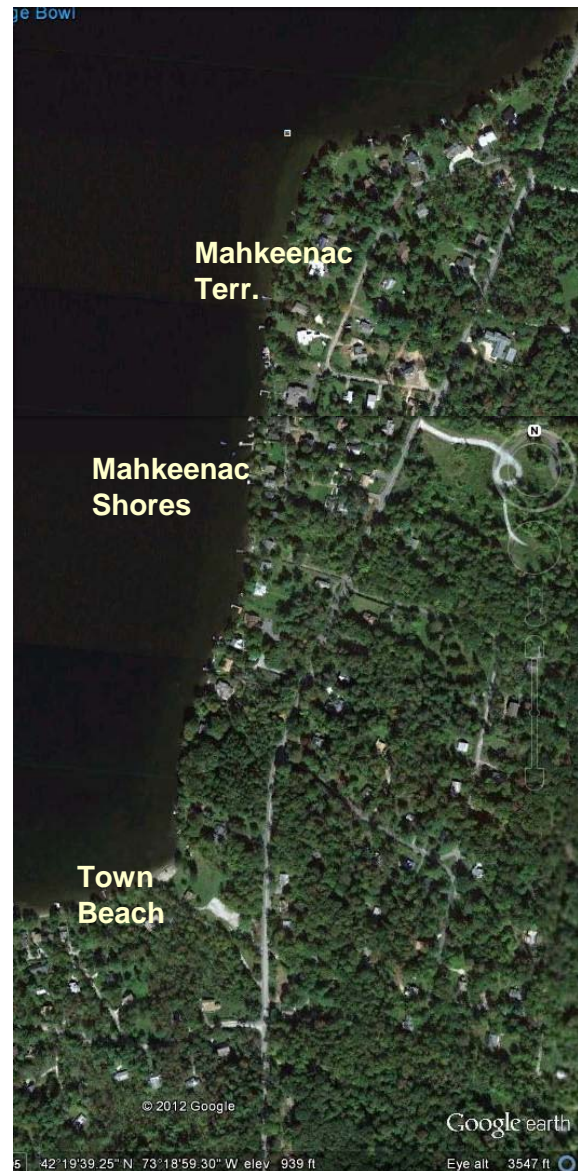
- a) Drainage ditches from the road systems all along this stretch of the lake should be individually assessed.
- b) There is a white discharge pipe that should be assessed (see photo for location).

- c) Few of the homes have shoreline vegetation.
- d) Mahkeenac Shores park supports very little vegetation. What is there is compacted and stressed from use.

- e) The drainage ditch next to Mahkeenac Shores beach is significant sediment deposition.
- f) The northern stretch of Mahkeenac Road has a road drainage system that concentrates and discharges runoff into ditches that flow into the lake untreated.

- g) The construction site cross from the Town Beach driveway was discharging sediment-laden into the road stormdrain system in the spring of 2012.
- h) Runoff from the Town Beach parking lot and driveway is carving gullies and carrying the sediment-laden flow into the lake unimpeded.

- i) Beach sand from the Town Beach is eroding into the lake. (NOTE: New England Environmental, Inc. designed a plan to control stormwater runoff at the Town Beach as part of the s.319 NPS grant project).

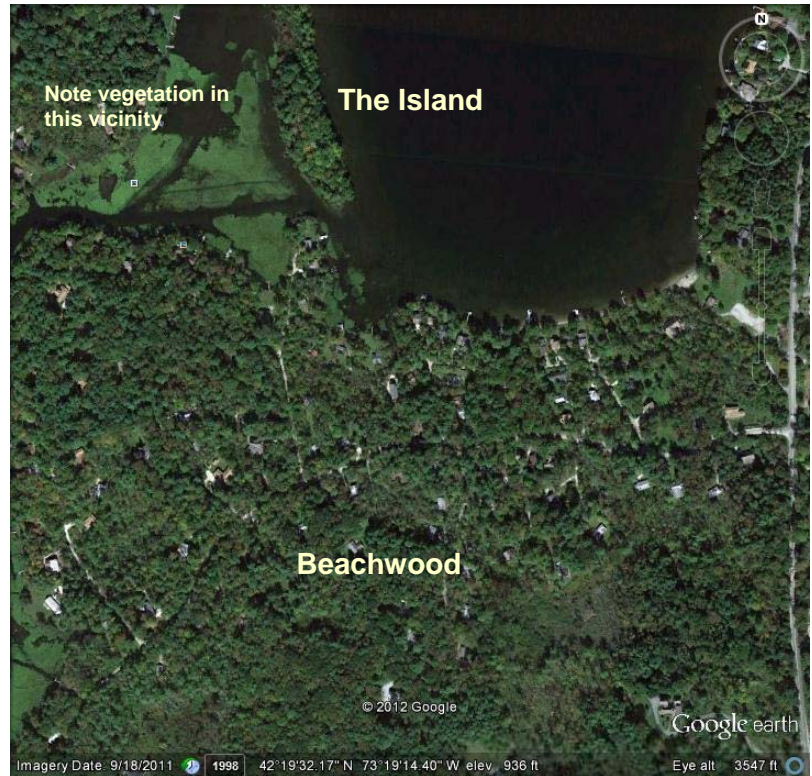
- a) Many of the properties maintain lawn right to the water's edge, lacking shoreline vegetation.
- b) There is a home on Lakeview Drive, on the eastern shoreline of the outlet that contains several areas of exposed along a path on a steep slope.
- c) There is a white PVC drain pipe on a property on Lakeview Drive.
- d) A house that sits high on a hill on the southern end of the outlet channel has a very large lawn with little shoreline vegetation.
