Lee ADA Self-Evaluation and Transition Plan

June 2024

Berkshire Regional Planning Commission

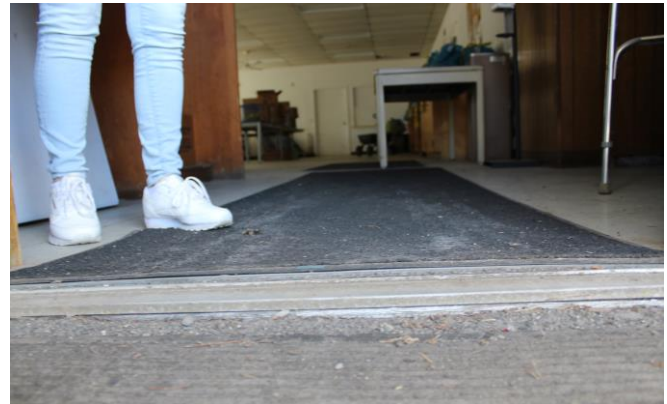
The transition into the building from the Railroad Street side is no longer smooth because the outside surface eroded.

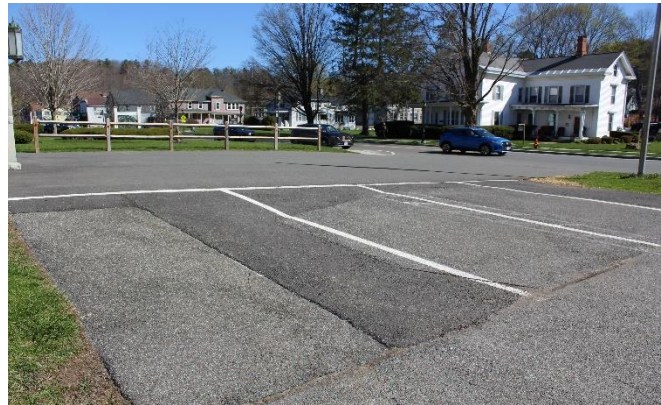
There is sufficient space to add accessible parking.

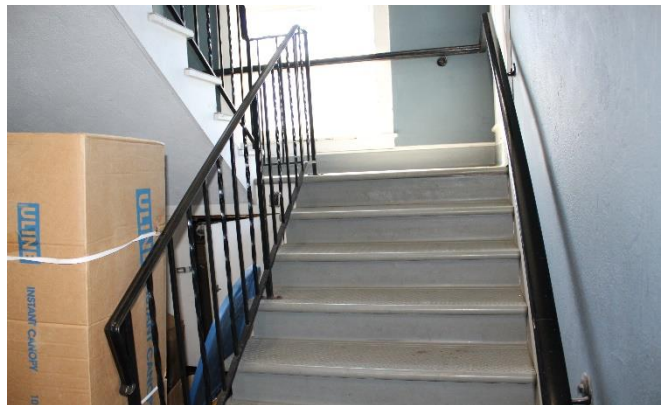
The only access to the second floor is up a staircase.

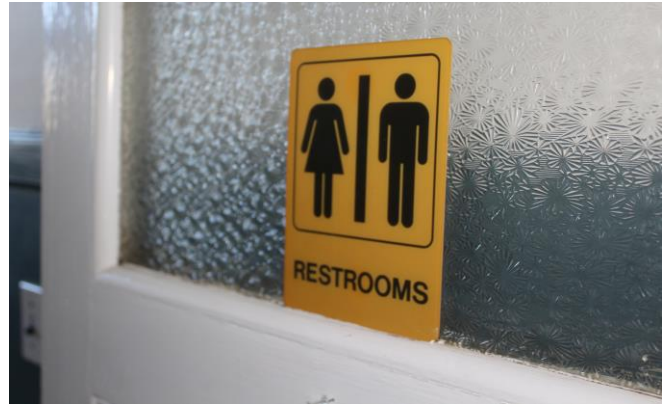
The bathroom does not have a tactile or braille sign. The town anticipates that it will demolish the Airolidi Building soon. The town intends to demolish the Airolidi Building in the coming years.

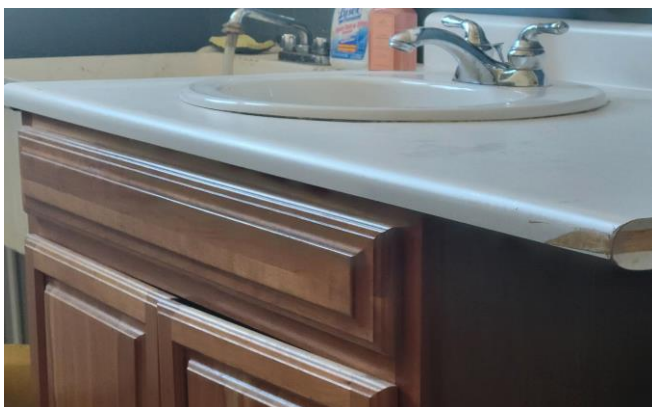
The sink is too high.

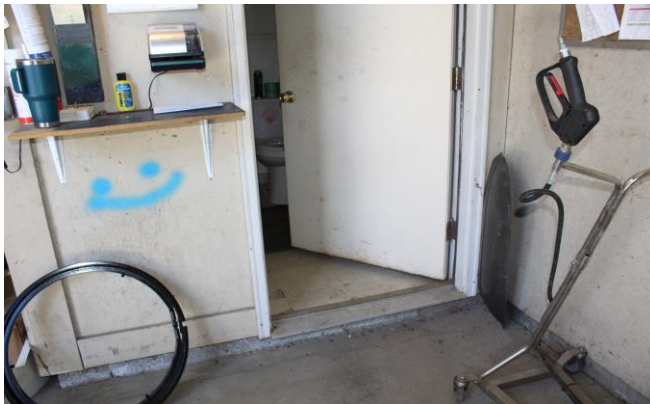
Cracks in the floor in the basement can be a barrier.

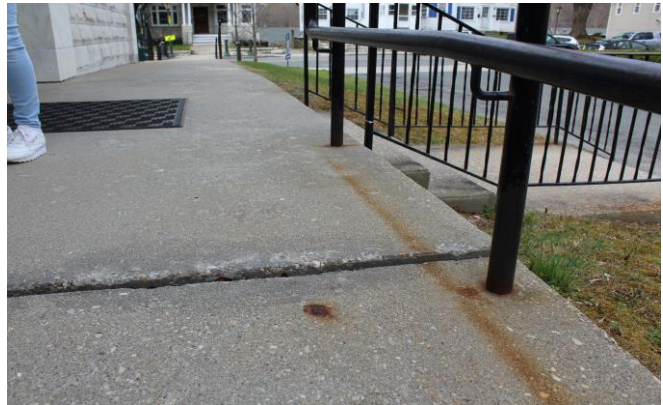
While still in compliance, a small lip is forming on the ADA ramp which the town should monitor.

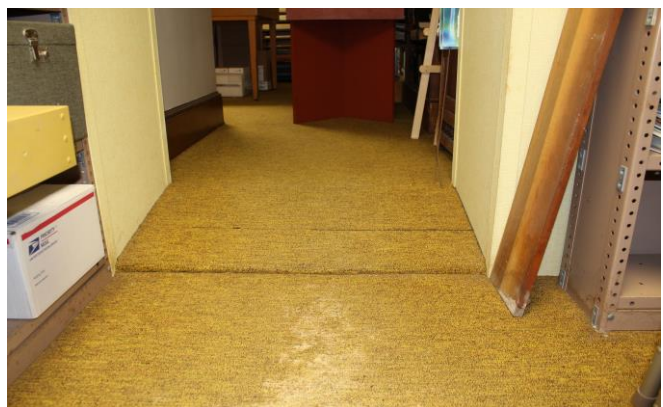
The change in level makes it difficult for someone to maneuver from one room to another in the basement.

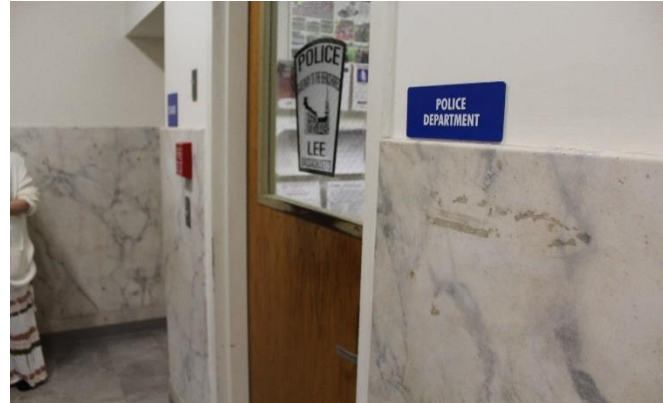
After entering the Police Department, patrons are immediately met by a counter. There is not enough room for someone to close the door and turn around.

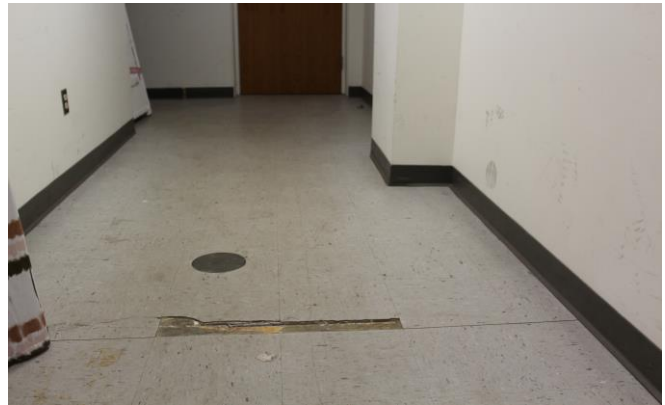
Cracks in the floor in the basement can be a barrier.

The hallway to the booking room and holding cells has cracks, which can trip up someone with limited mobility or difficult seeing. The ADA standards require floors to be firm and slip-resistant and that there are no changes in level beyond 1/4 of an inch. At the end of a hallway currently used to house custodian equipment, there are broken tiles to the exit, creating a difficult transition.

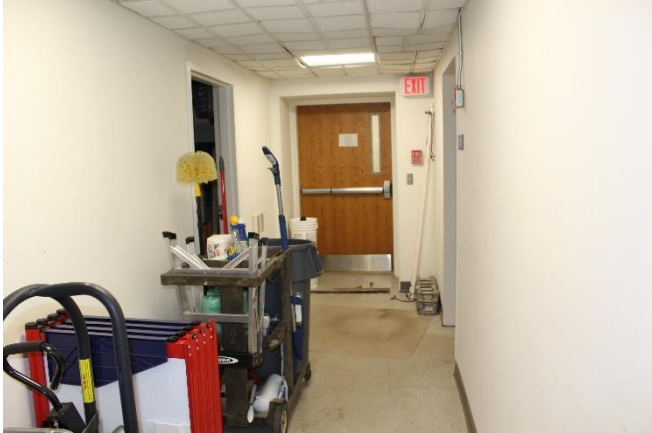
The hallways are cramped and do not allow someone in a wheelchair to turnaround. The floor features multiple broken tiles.

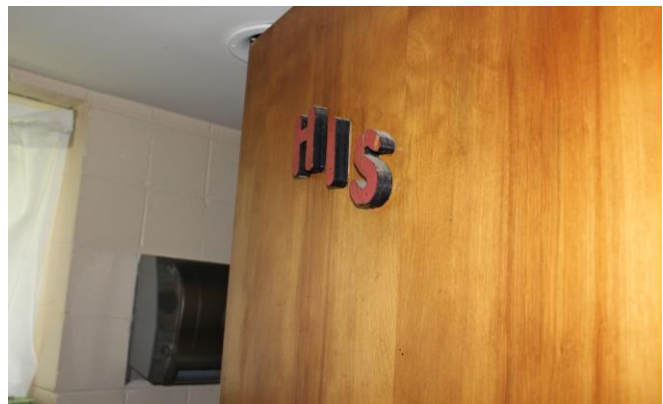
The bathrooms lack proper signage.

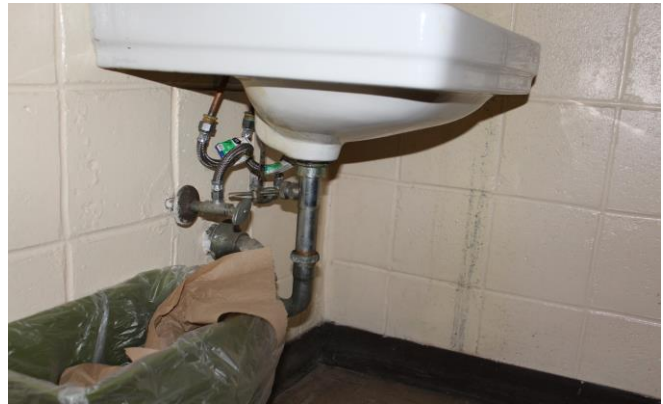
There are exposed pipes under the bathroom sink.

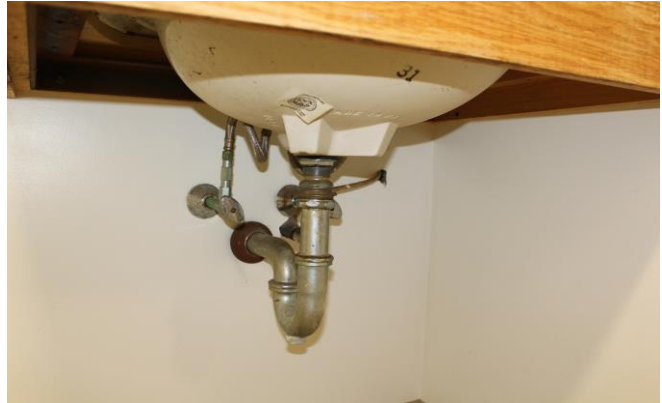
Both bathrooms have exposed pipes under the sink.

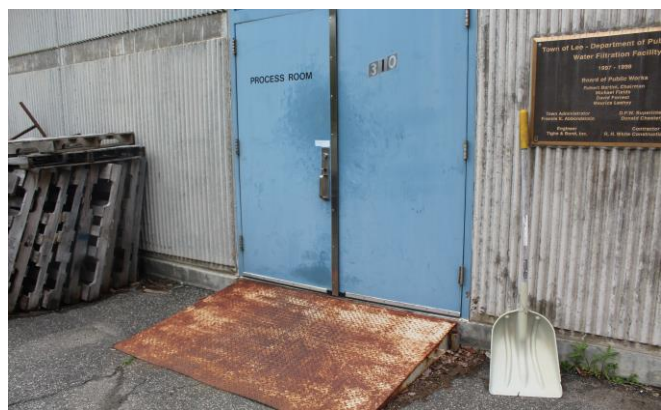
The building is not accessible.

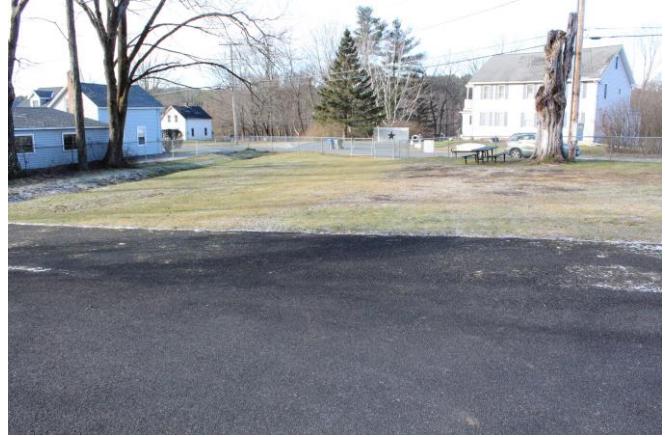
There is no accessible pathway through the park.

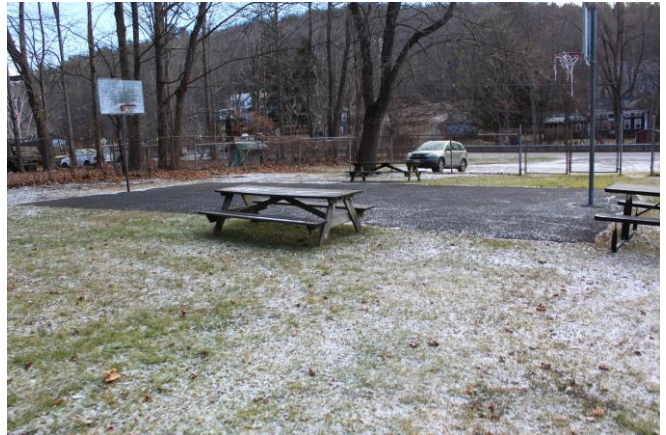
There is no accessible pathway through the park.

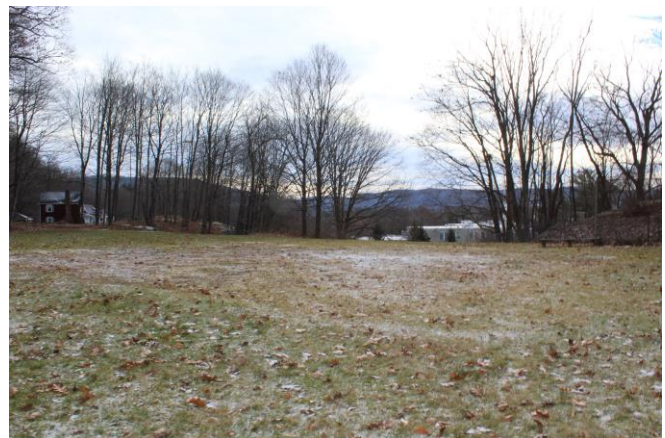
There is no accessible pathway through the park.

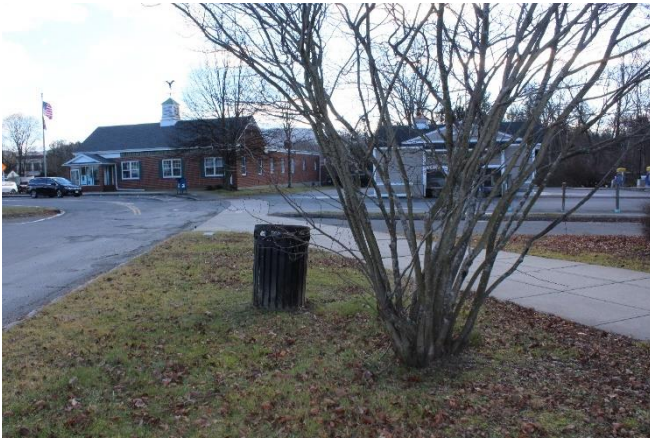
The garbage can is not close enough to the accessible path.

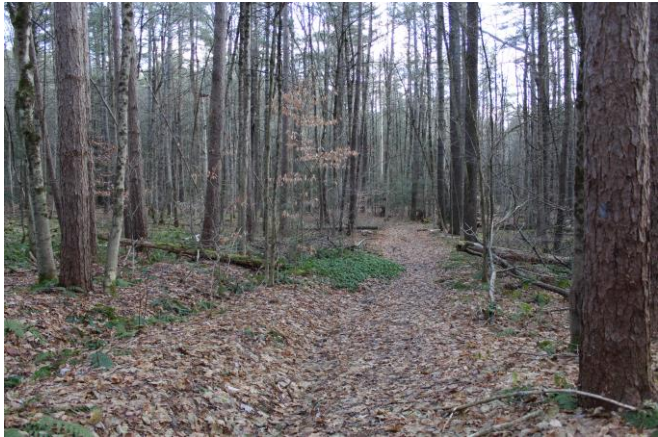
There is no accessible pathway through the park.

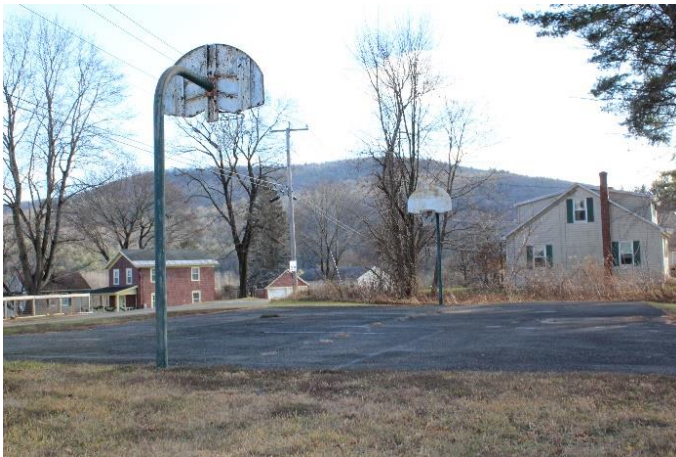
The basketball court could use a resurfacing to eliminate heaving.

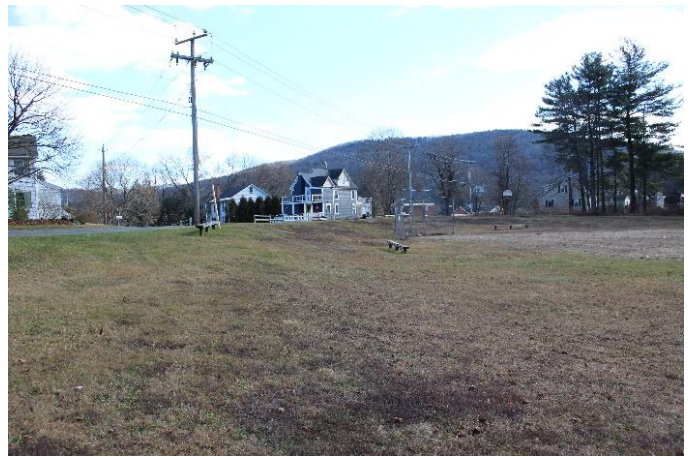
Improving access to the baseball field will require a significant amount of regrading and paving.

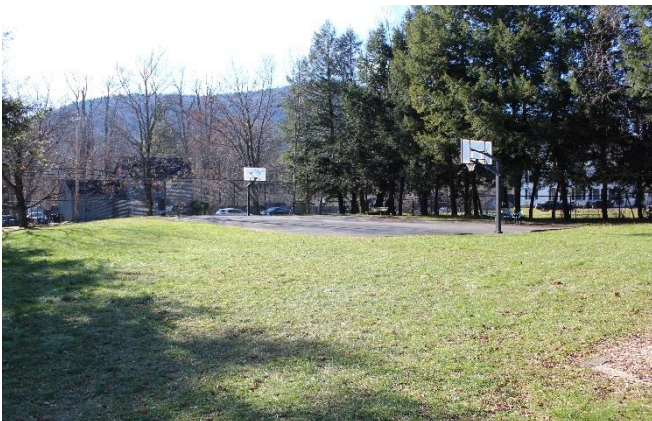
There is no accessible path through the park.

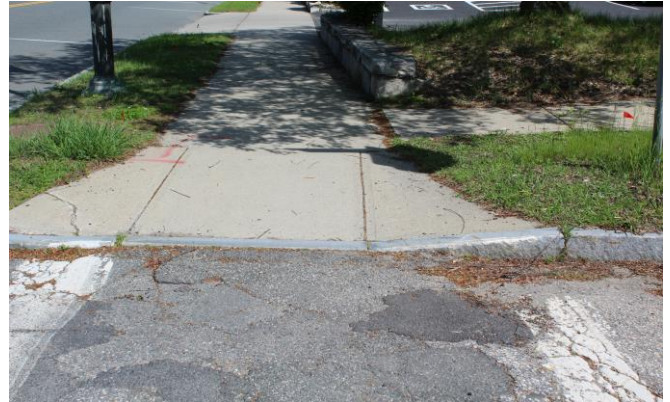
There are no curb ramps at some of the intersections with side roads in the downtown. The roads that the town has not reconstructed recently also have worn pavement, limiting accessibility.

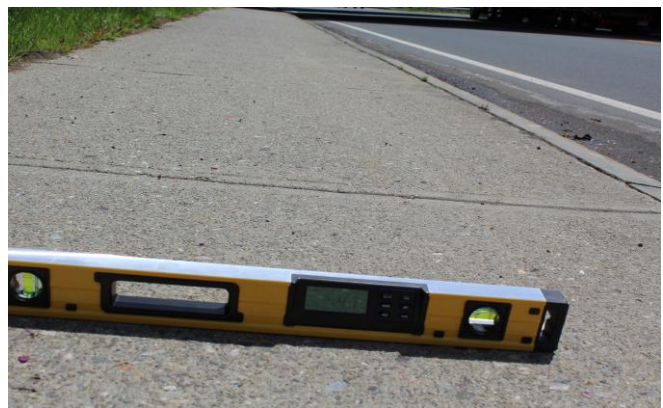
There are several locations on Housatonic Street and High Street where the cross slope exceeds the maximum 2% slope.

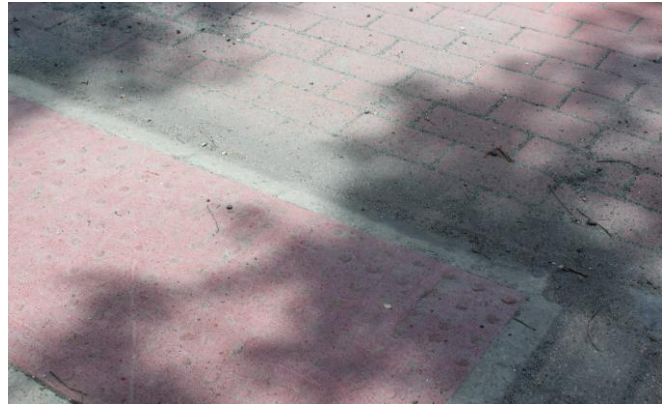
Many of the detectible footings have worn, most notably along Housatonic Street.

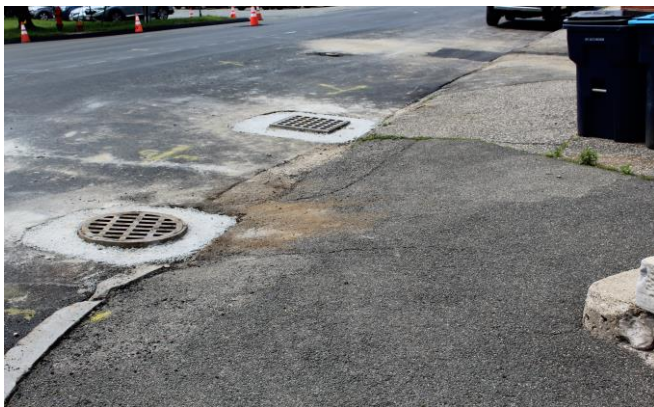
The sidewalks throughout Railroad Street are in need to replacement.

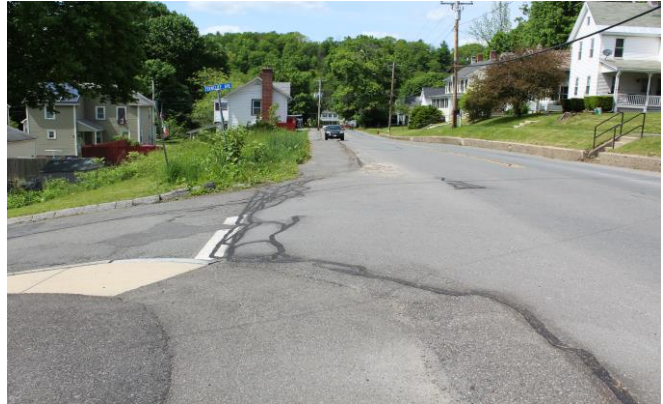
The typography poses significant challenges in connecting the residential area of High Street with the downtown.
