# ROAD SAFETY AUDIT

## BMC Area Traffic Circulation Improvements

City of Pittsfield

FINAL REPORT April 7, 2016

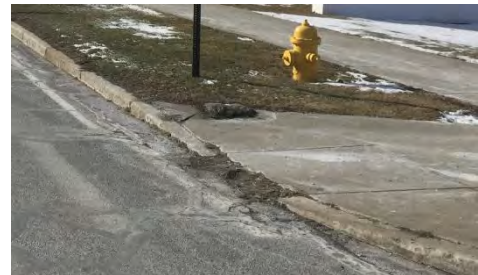
- **Pedestrian Infrastructure:** Pedestrian accommodations are not compliant with current standards. Pedestrian ramps do not include detectable warning panels, push-button actuation, signal countdown display, or Accessible Pedestrian Signals (APS). Some of the existing sidewalks are in poor condition, which could present a tripping hazard.

Image 1: Pedestrian ramp on North Street, south of BMC driveway

- **Pedestrian Infrastructure:** Repair or replace heaved and damaged sidewalks to eliminate tripping hazards. Update the ramps and pedestrian signal equipment to current ADA standards. Bi-directional apex ramps should be replaced and avoided with future improvements. The goal of these improvements is to provide safe, accessible infrastructure for all pedestrian users.

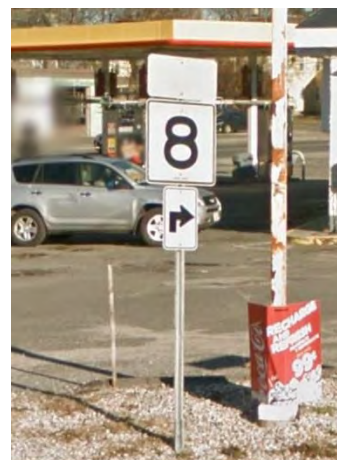
- **Signage:** Traffic control signs at and near this intersection are severely faded and are no longer effective for traffic control. Image 2 shows a “No Left Turn” sign with the legend faded.

Image 2: Faded route marker sign

- **Solar Glare:** Faded traffic signs should be replaced with new, MUTCD compliant signs. The locations of the signs shall be reviewed and signs need to be moved to optimal locations to reduce the solar glare impacts.

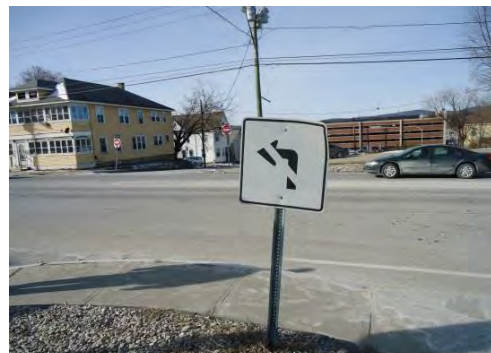
- **Access Management:** There is a 42-foot driveway opening on the east side of First Street just north of the intersection with Burbank Street for the Shell gas station. This driveway is one of three curb-cuts for the gas station. During the audit, participants observed vehicles making an illegal left-turn from the driveway. Left-turning vehicles from this driveway are a potential contributing factor to angle collisions the Burbank Street intersection. Left-turns exiting the driveway are competing for gaps southbound on First Street with vehicles eastbound on Burbank Street. Angle Crashes such as numbers 5, 6, and 12 may have been caused by this issue. In addition, left-turns entering and exiting the Shell driveway must cross the queued traffic for the signal at the intersection with Tyler Street.

Image 3: “No Left Turn” sign at the gas station driveway, north of Burbank Street

- **Signage:** Replace non-compliant, worn and damaged signs. Re-locate signs to the correct locations improving visibility.
- **Access Management:** Work with the owner of the 42-foot driveway to eliminate it or provide channelization prohibiting left turns out of the driveway. Consider installing a raised median to reinforce the left-turn prohibition out of this driveway.

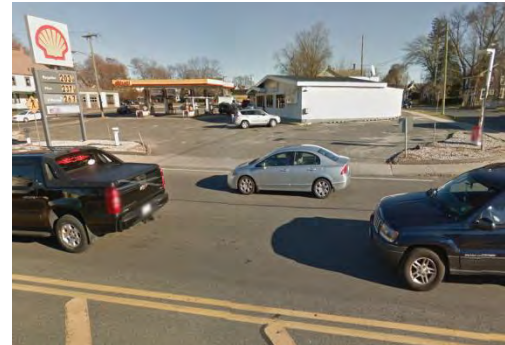
- **Poor Compliance with Turn Prohibition:** As stated under the previous issue, vehicles make an illegal left-turn from the driveway Shell gas station driveway. Participants also noted the poor condition and placement location, to the left of the driveway and away from exiting vehicles, of the existing “No Left-Turn” sign (R3-2L). The driveway is 42 feet wide without channelizing geometry or physical barrier that would discourage left turns from the driveway. Image 4 shows this wide driveway.

Image 4: Looking easterly at the 42-foot gas station driveway, north of Burbank Street  
Source: Google Maps

- **Poor Compliance with Turn Prohibition, Cut-Through Traffic and First Street at Tyler Queuing:** Driveway and roadway improvements are recommended at the 42-foot driveway location to prohibit the left turns out of this driveway. Geometry improvements to the driveway in the form of channelizing the right-turns in and out of the driveway, as well as installing a raised median on First Street, would provide physical barriers to discourage left-turns out of this driveway. R3-2L “No Left Turn” sign should be relocated to the right side of the driveway and installed on the opposite side of First Street. It is recommended that the City of Pittsfield work with the property owner to reduce the width of the driveway or eliminate it all together.

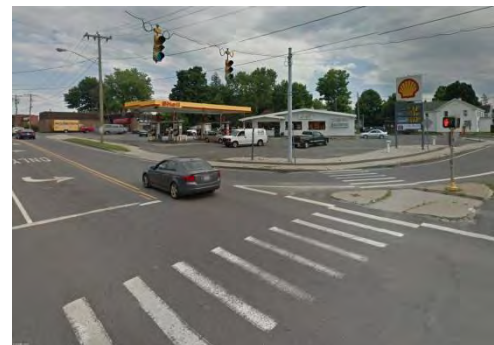
- **Signage:** Many of the traffic control signs in the vicinity of this intersection are faded and/or not compliant with the current standards for retroreflectivity. The advanced pedestrian crossing sign (W11-2) for the channelized right turn is partially blocked by the gas station sign.

Image 5: Gas Station driveway to the west of the intersection. Source: Google Earth

- **Signage:** Replace all traffic signs that are not compliant with MUTCD or are worn or damaged. Relocate signs to correct/unobstructed locations improving visibility.

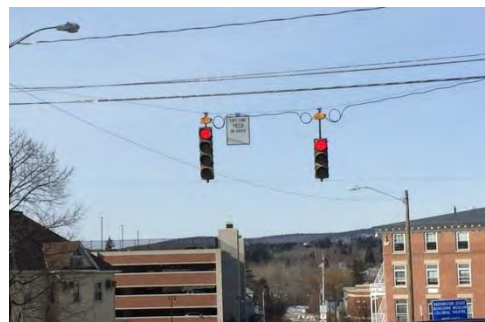
Image 6: Green ball is faded on R10-11 sign. Tyler Street west approach.

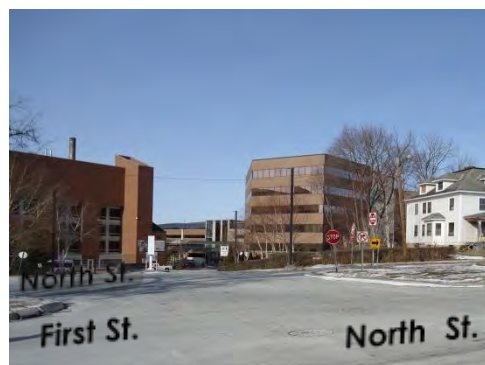
- **Close Proximity of Two Intersections:** The two intersections are only separated by approximately 50 feet. This close proximity results in significant impacts to typical traffic operations at both intersections. Inherent with the non-standard configuration is an overlap of the conflict points associated in the two intersections, which is exacerbated during peak hour congestion. Based on the equivalent property damage only (EPDO) method of identifying high crash locations, the intersection is located within the top 5% of high crash locations. Nearly all crashes are angle collisions (15 of 19 crashes) where failure to yield right of way was cited

Image 7: Looking from Stoddard Avenue approach across First and North Streets towards BMC Driveway.

as a reason for the crash. The close proximity and non-standard configuration of the two intersections was noted by the audit participants as a cause or contributing factor to this issue.

- **Close Proximity of Two Intersections:** The audit team recommended consideration of constructing a roundabout to replace the two intersections. This improvement would address the close proximity of the two intersections by configuring all approaches into a single roundabout. This would also have the benefit of simplifying the currently confusing right of way. Roundabouts are proven to reduce crash severity and improve overall safety. Minimum volume warrants are not required for roundabouts.
- **Confusion of Right of Way:** Two suggestions were made during the audit to clarify the confusion over right of way between vehicles at the two intersections. First, a warrant review

installation of a traffic signal should be conducted. The approaches could be brought to a single intersection point under one signal or signalized as two separate intersections. Signalization would be expected to reduce right of way confusion and decrease the experience of angle crashes. A second alternative was eliminating the southbound one-way slip lane. This would reduce the number of approaches at the westerly intersection with the BMC driveway. The immediate stop condition on the short east approach is not needed if the slip lane approach from the north is eliminated, which simplifies the right of way. This alternative requires modifying the planter in the island north of the intersection between the existing slip lane and North Street to improve the sight line from the BMC driveway.

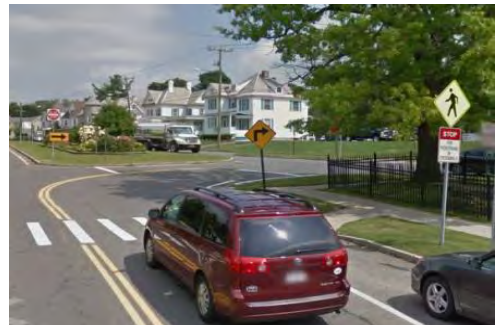
- **Sight Lines:** Participants noted the following sight line restrictions on intersection approaches.
  - The fencing on the west and east side of First Street along with traffic signs obstruct the sight lines for drivers crossing First Street.

Image 9: Looking north from North Street near the BMC Driveway Source: Google Maps

- **Sight Lines:** The City should work with property owners in the vicinity of the intersection to provide clear sight lines for drivers. The following are recommended:

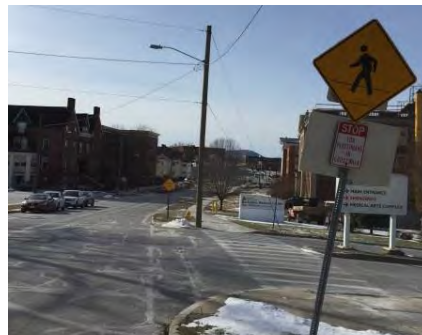
- The pedestrian crossing warning signs (W11-2) on North Street southbound and First Street southbound were installed at inappropriate locations. The W11-2 located on the one way North Street southbound approach is located north of the BMC driveway, but the closest crosswalk is located south of the driveway (refer to Image 10 above). A “Hospital Zone” sign is mounted at the North Street crosswalk. The First Street southbound facing W11-2 is installed beyond the crosswalk located and may direct the driver to look for pedestrians in the wrong location.

Image 10: Ped crossing sign located in advance of the crosswalk.

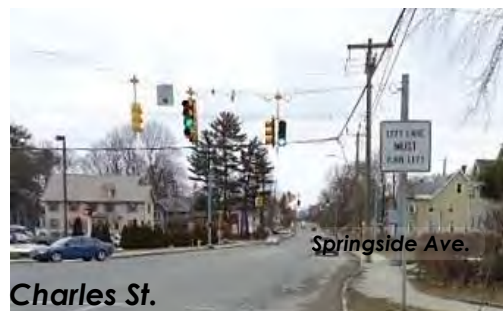
- **Traffic Signal Heads:** Participants noted that the easterly head assembly on the span wire is twisted out of alignment. This condition affects the North Street northbound approach and the Charles Street eastbound approach where the signal indications are partially obscured. The northbound and southbound heads are not equipped with backplates. The eastbound traffic signal heads have backplates. Of

Image 12: Looking north from intersection with Charles Street.

the six crashes reported at this intersection four were rear-end collisions with three occurred northbound on North Street. Drivers may be confusing the signal indications at Charles Street with the indications at Springside Avenue, which is located approximately 150 feet to the north.

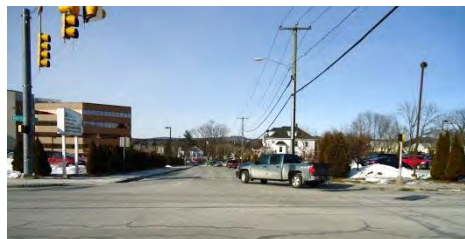
- **Signage:** The northbound lane designation signs are blocked by utility and mast arm poles.
- **Lane Geometry:** The westbound lane width on Charles Street is narrow to accommodate an auxiliary left-turn lane. Participants noted that drivers turning onto Charles Street encroach on the opposing lane. The condition may be a contributing factor to crash number two.

Image 13: Drivers encroach left-turn lane when turning onto Charles Street.

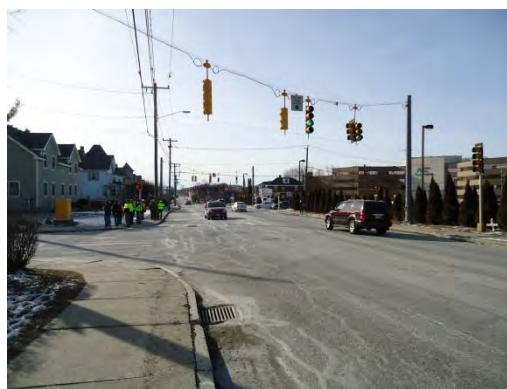
- **Southbound Rear-end Pattern:** A review of the crash data for this intersection indicated a pattern of rear-end collisions southbound on North

Image 14: North Street looking south at North/Springside intersection.

Street, which accounted for seven of the 17 collisions. The rear-end crash pattern includes crash numbers 1, 2, 3, 8, 11, 14, and 16. Audit participants discussed potential safety issues and review field conditions with the following observations:
