# North Adams ADA Self-Evaluation and Transition Plan

June 2025

Berkshire Regional Planning Commission

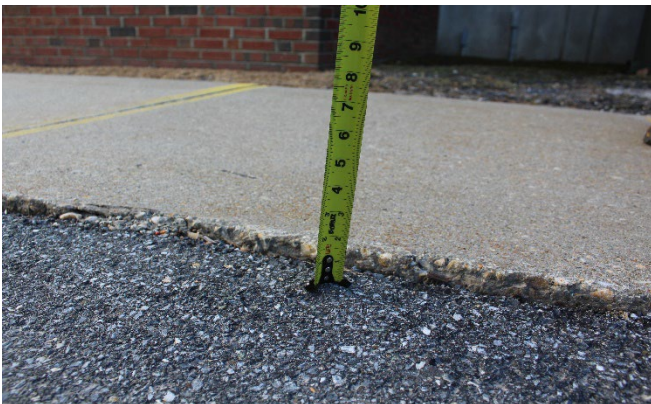
There is a change in level at the intersection between the parking lot and the curb ramp.

There is an accessible route from the parking lot to the front entrance of the building. The route is demonstrating signs of wear and tear. There are multiple locations where the sidewalk's deterioration created changes in levels, including the curb cut from the parking lot to the accessible route, and trip hazards. The city should plan for significant sidewalk repairs.

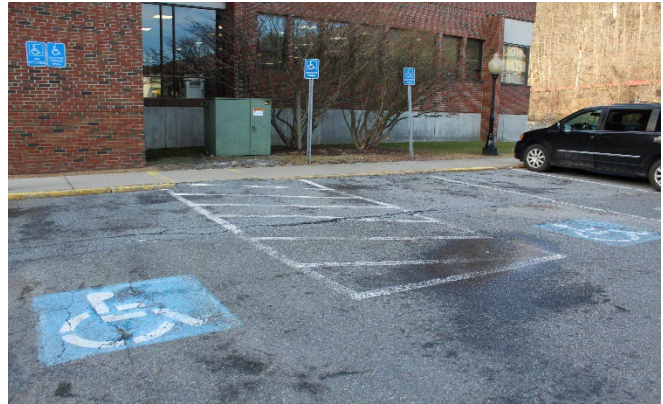
There is no aisle access in the accessible space to the far right.

**The city should install a five-foot aisle next to the space currently without one.**

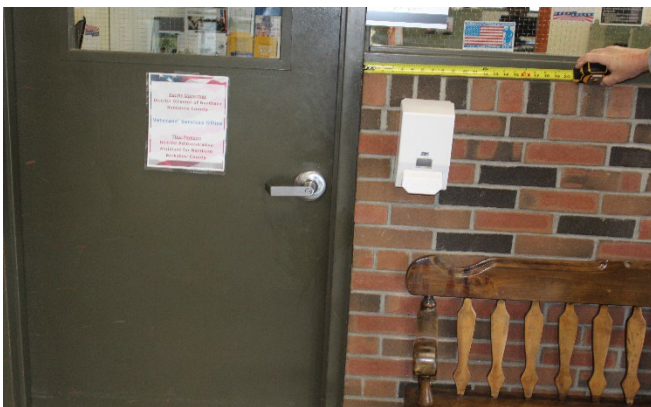
The bench encroaches on the signage for the Veterans' Services office.

The city can move that bench to another location to ensure accessibility.

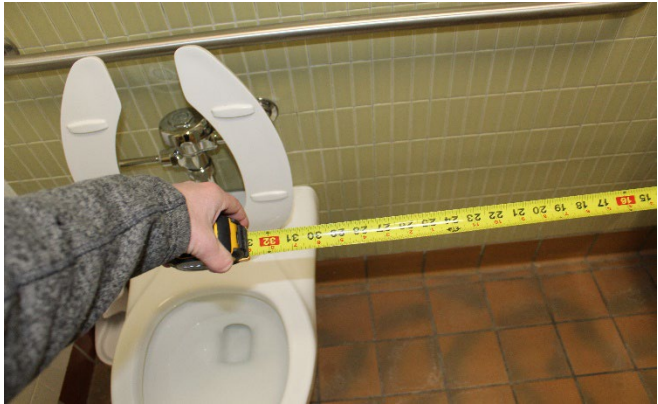
There is insufficient space from the far wall to the toilet.

MAAB 30.1 (a) requires at least one wheelchair accessible stall in public buildings. There is insufficient space in the restroom for a fully compliant wheelchair accessible stall. The stall must be at least 60” wide, according to 604.8.1.1 of the 2010 ADA Standards. The stalls at City Hall do not provide that width.

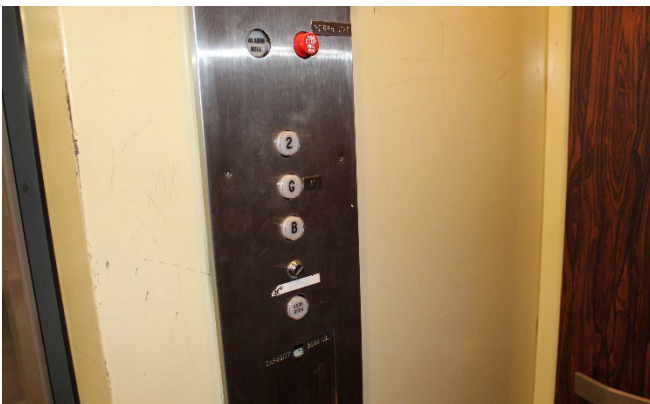
The elevator is missing braille and tactile control identifications as defined in Table 407.4.7.1.3 of the 2010 ADA Standards.

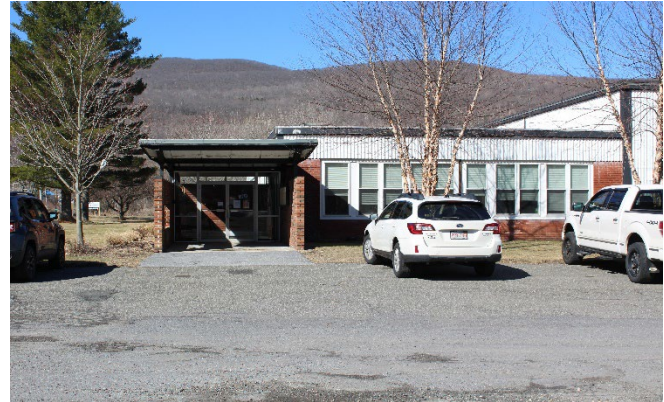
There is no accessible parking on site. The parking lot is paved, providing an accessible route into the building, but none of the spaces are defined. The city needs to define the parking area to determine the number of accessible spaces required and appropriately install accessible parking.

There is no accessible parking on site.

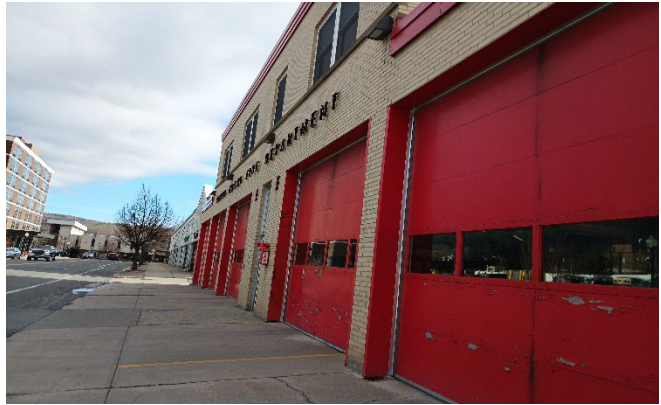
The Fire Department is not accessible.

There is a toilet room located in the garage space the public can use. The restroom is not access for numerous reasons including, but not limited to, inaccessible sink, no grab bars, improper door hardware, and toilet paper and mirrors are not appropriately located.

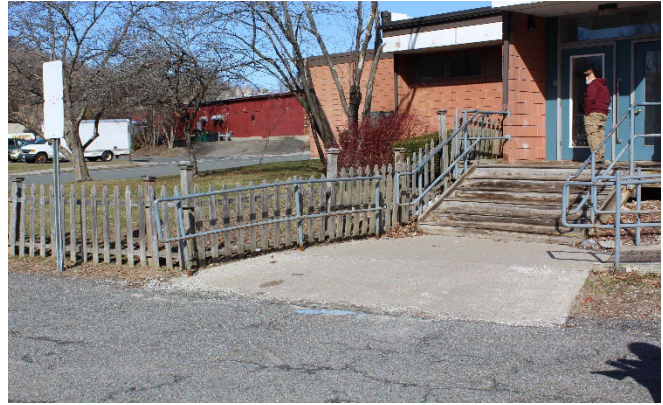
The Spitzer Center is home to the Council on Aging. The accessible parking space sign and lines are faded and there is a change in level from the parking lot to the accessible walkway.

The transition currently has a change in level above the  $\frac{1}{4}$ " allowed in the 303.2 of the 2010 ADA Standards and 521 CMR 26.10.1. The city needs to repair the concrete at the entrance to ensure a smooth transition into the building.

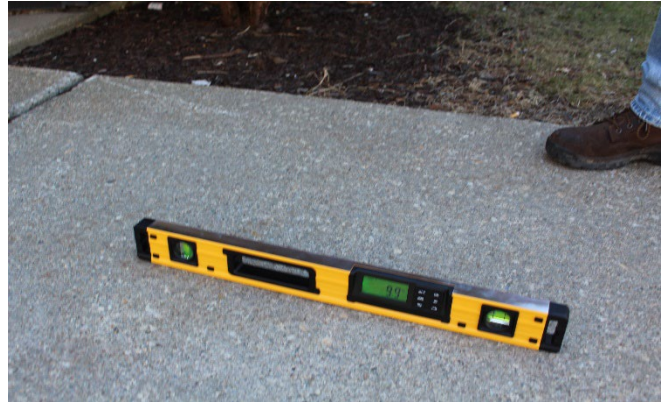
The walkway into the Ashland Street entrance is too steep.

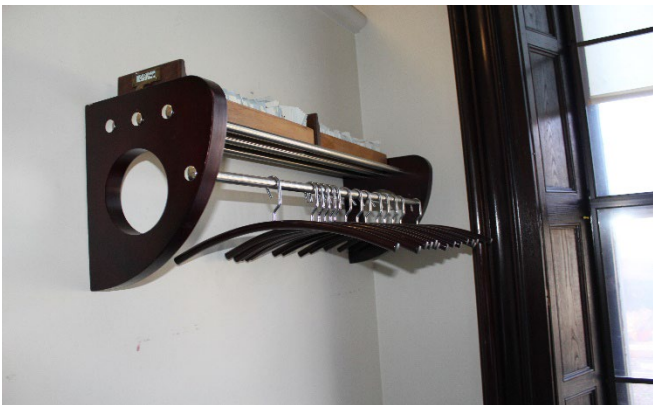
A coat rack is out of reach ranges.

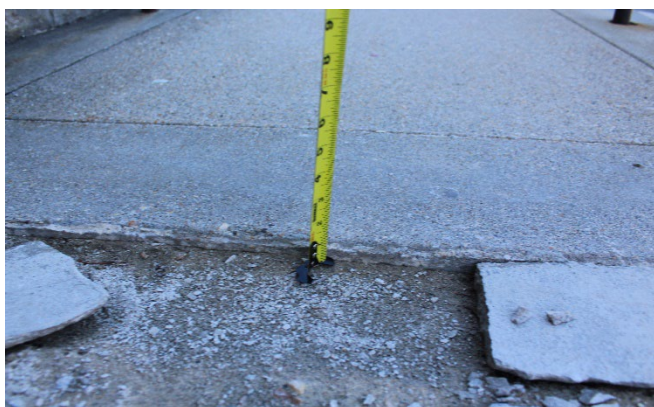
The parking lot is firm and appropriately sloped. However, the concrete at the ramp is deteriorated creating a change in level above  $\frac{1}{4}$ ", which is the maximum allowed in 303.2 of the 2010 ADA Standards and 521 CMR 22.4.

The concrete at the ramp is breaking down.

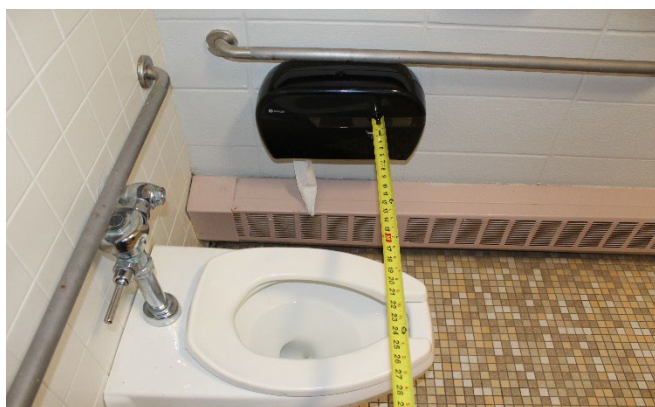
The toilet paper dispenser is not located 7"-9" from the edge of the toilet seat as defined in 604.9.6 of the 2010 ADA Standards and 521 CMR 30.7.6. Additionally, the location of the toilet paper dispenser infringes on the required 18" of space from the center of the toilet to the wall required in 604.2 of the 2010 ADA Standards and 521 CMR 30.7.2.

The centerline location of the toilet paper dispenser needs to be 7"-9" from the edge of the toilet seat.

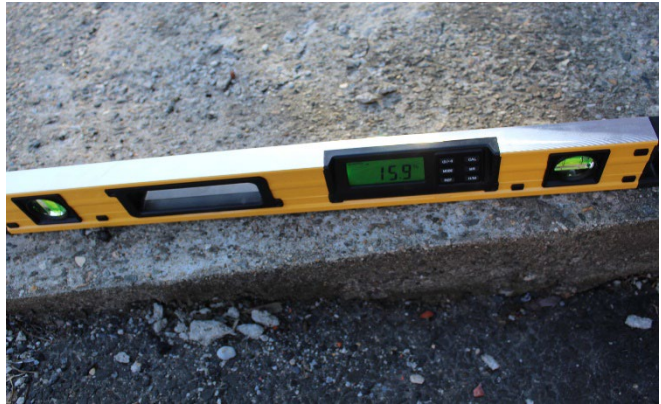
The ramp to provide access into the building is significantly steeper than the ADA limits.

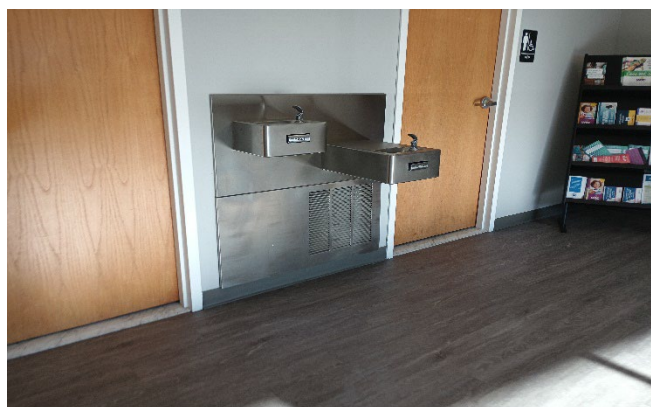
There is a compliant water fountain located in the lobby. However, it does act as a protruding object.

The fountains are accessible but act as a protruding object.

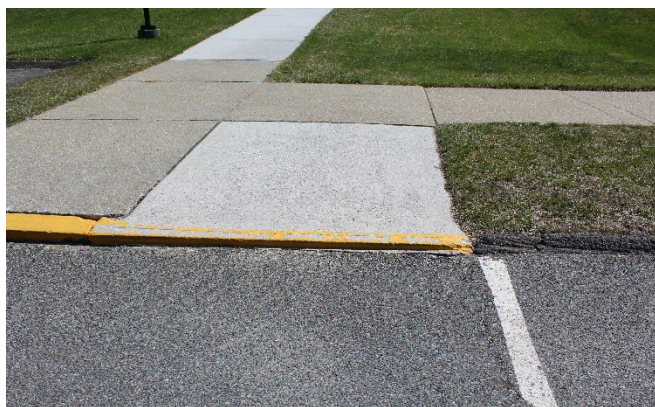
At the entrance to the building the threshold is no longer flush with the concrete, creating another change in level which is not in accordance with 303.2 of the 2010 ADA Standards and 521 CMR 22.4.

The curb cut is not compliant, limiting access from the accessible parking to the walkway into the building.

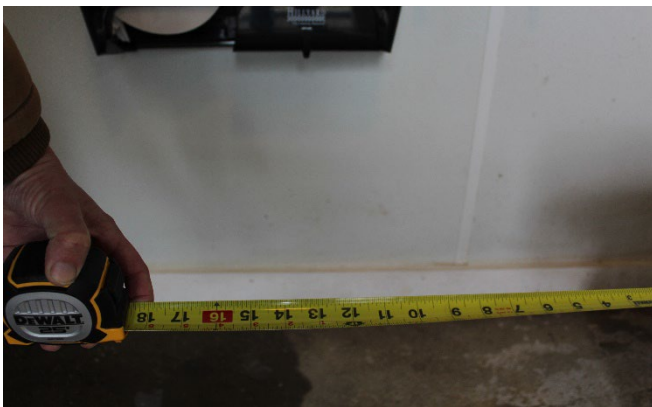
The toilet paper dispenser is too far from the toilet.

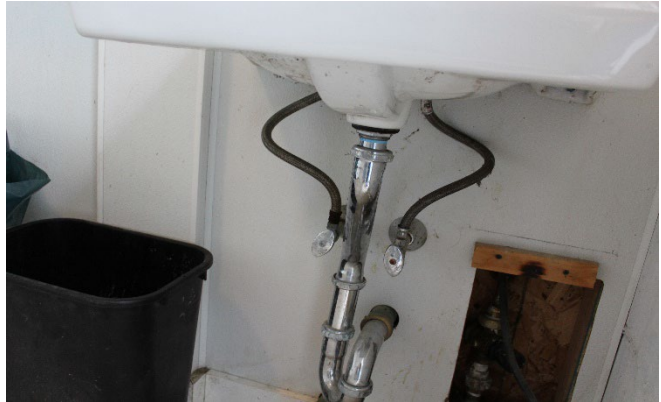
The drainage pipes under the sinks in both facilities are exposed, which is not in compliance with 606.5 of the 2010 ADA Standards and 521 CMR 30.9.5. The pipes should be insulated or guarded.

Bathroom piping should be insulated or guarded.

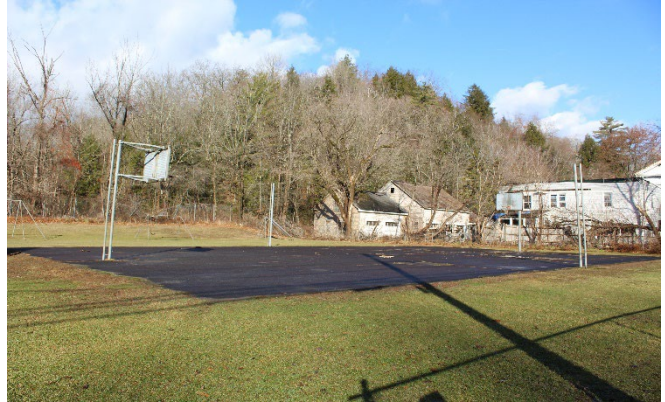
There are no accessible paths connecting the elements at the park in accordance with 206.2.2 of the 2010 ADA Standards and 521 CMR 20.2.1. The playground must be on an accessible route in accordance with 1008.2 of the 2010 ADA Standards and 521 CMR 19.7.

There are no accessible paths to the park elements.

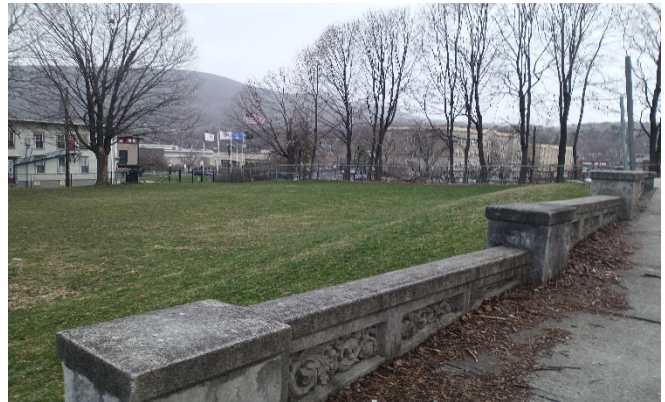
The walkway in the park provides an elevated view of the grassy area but there is no route to access it and it has a slope that exceeds standards.

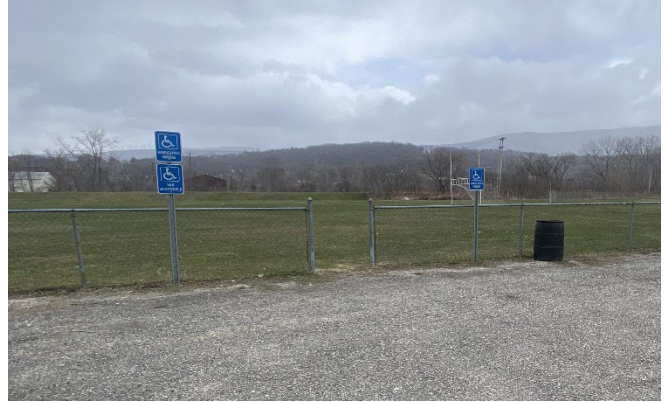
There is a firm, asphalt parking area with two signs identifying accessible parking. The parking spaces do not have any lines to define the spaces. 521 CMR 23.4.5 require cities to mark spaces with high contrast paint. The ADA requires in 503.3.3. that van accessible spaces have aisle markings to dissuade people from parking in those spaces.

The spaces are not marked.

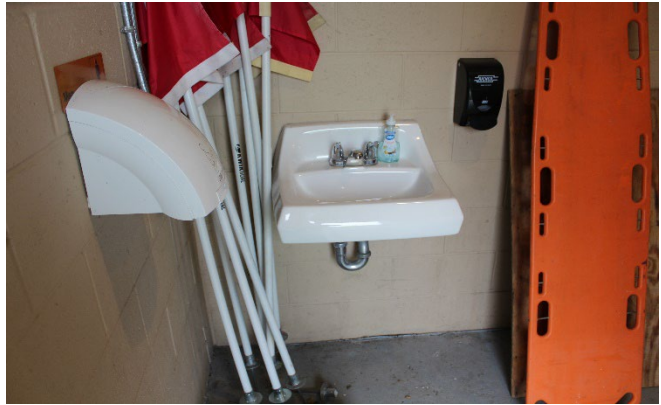
The hand dryer imposes on the path of travel to the sink.

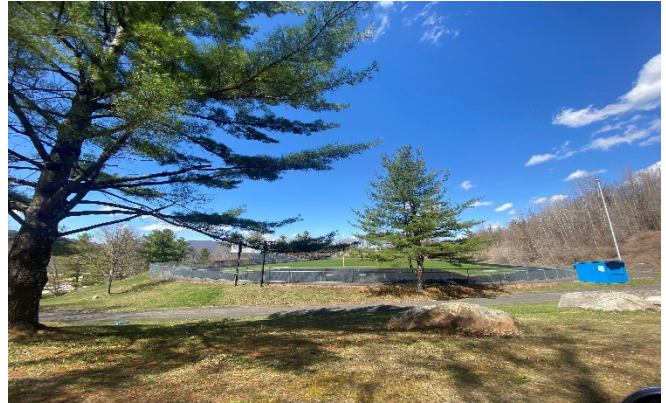
The track is not accessible.

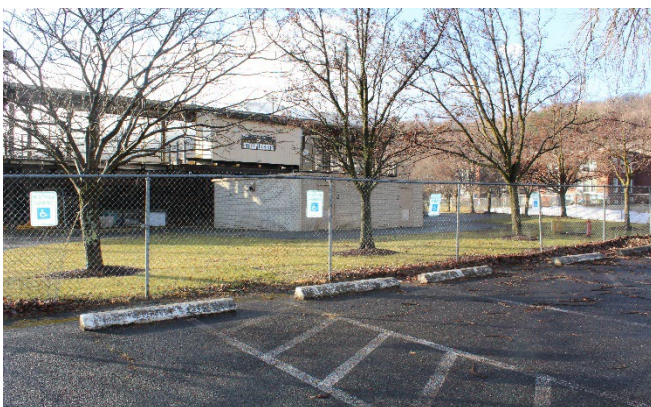
There is sufficient parking available on site, but the lines are beginning to fade and will need to be repainted soon.

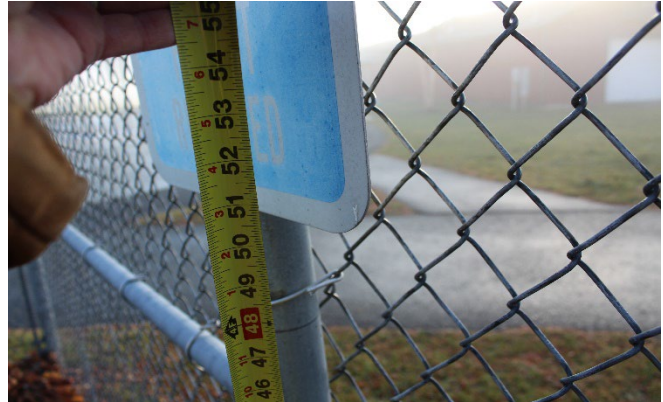
The signs measure at 50.5 inches above the ground, which is below ADA requirements.

The pavement in the parking lot and along the access route to Joe Wolfe Field are also beginning to crack and become unlevel. The city will soon have to repave to ensure a smooth surface in accordance with 302.1 of the 2010 ADA Standards and 521 CMR 29.1.

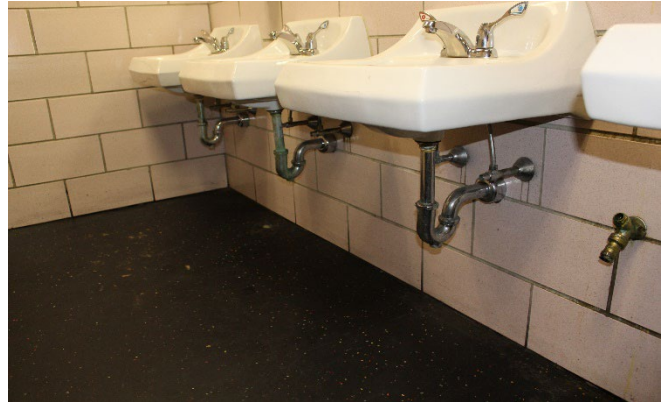
The pipes underneath the bathroom sinks are exposed.

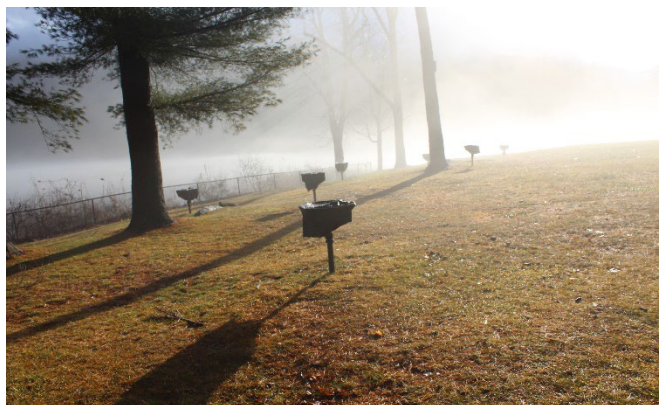
None of the grills are located on an accessible route.

Both are somewhat accessible. The playgrounds at the campground have an accessible ramp into the playground area but do not have an accessible path from the roadway to the ramp in accordance with 1008.2 of the 2010 ADA Standards and 521 CMR 19.7. The playground near the parking lot at Windsor Lake is not accessible in accordance with Section 240 of the 2010 ADA Standards and should be replaced.

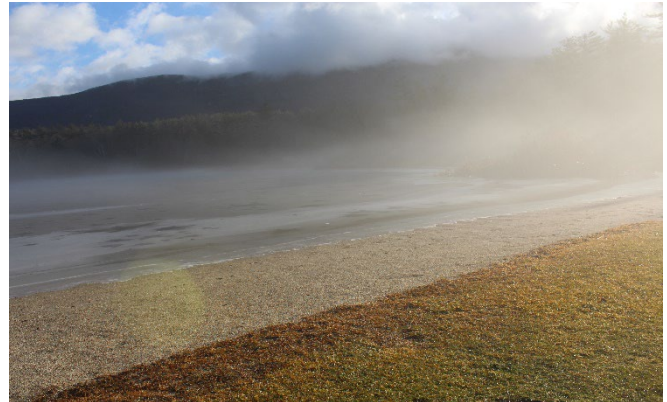
The city could improve accessibility at the beach by installing a firm surface, such as a Mobi-Mat, or providing access to beach wheelchairs.

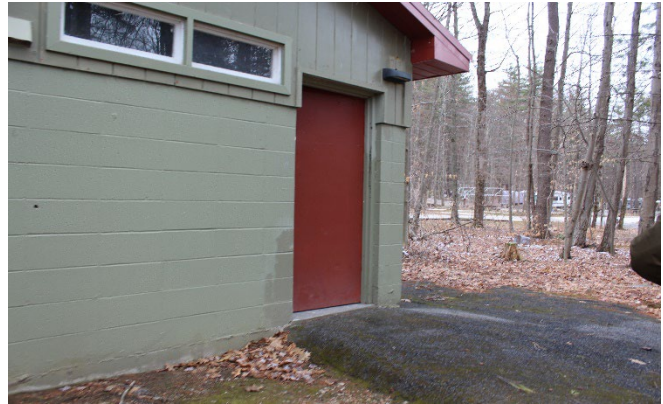
The pathway from the road to the accessible restroom does not have the appropriate grade.

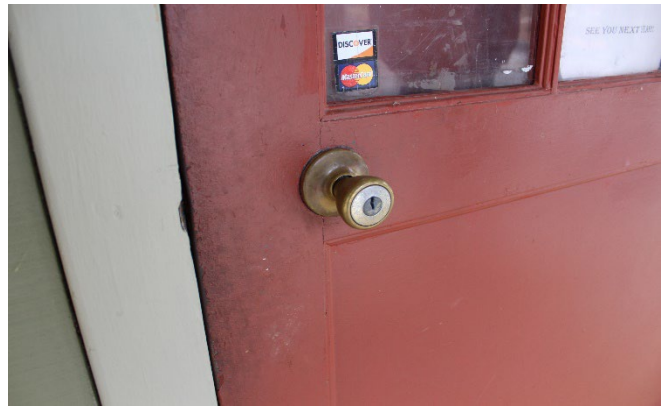
Door knobs are not in compliance with the 2010 ADA Standards.

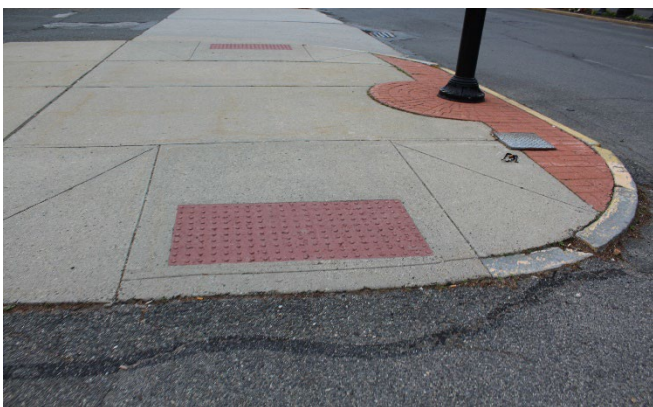
Curb ramps must meet specifications.

The running slope of a new curb ramp should not exceed 8.3%. Ramps steeper than 8.3% may not be usable for pedestrians in wheelchairs or scooters. Cross slopes are limited to 2%. The top of a curb ramp must have a level landing that is at least 48" deep. The side flares of a curb ramp are not intended for pedestrian travel but must meet certain specifications to eliminate tripping hazards. The foot of the curb ramp should be contained within the crosswalk markings. Pedestrians who use wheelchairs should not be directed outside of the crosswalk or into an active travel lane in order to cross traffic. If a diagonal ramp is used, a 48" bottom landing between the curb radius and curb line extensions.

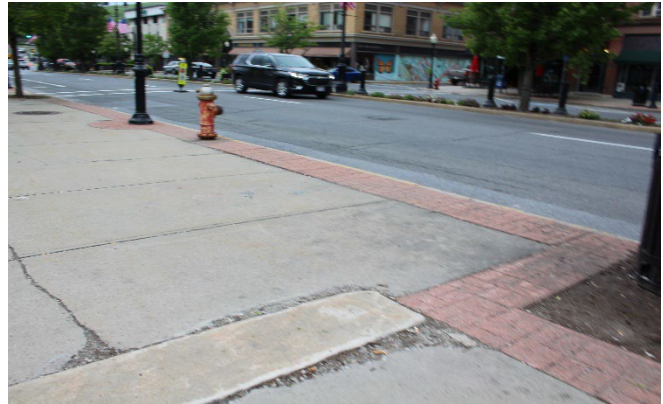
Sidewalks should be free of tripping hazards. Changes in level cannot exceed ¼".
