Lee ADA Self-Evaluation and Transition Plan

June 2024

Berkshire Regional Planning Commission

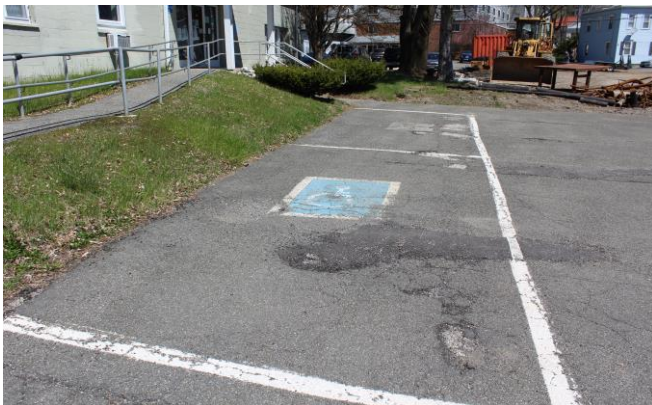
There is adequate parking available in the public parking lot on Railroad Street, but few spaces are designated as accessible. There is one accessible space located in the nearest location to the Airoidi Building but it does not have proper signage as required by 502.6.

The accessible parking space's lines are fading and there is not signage.

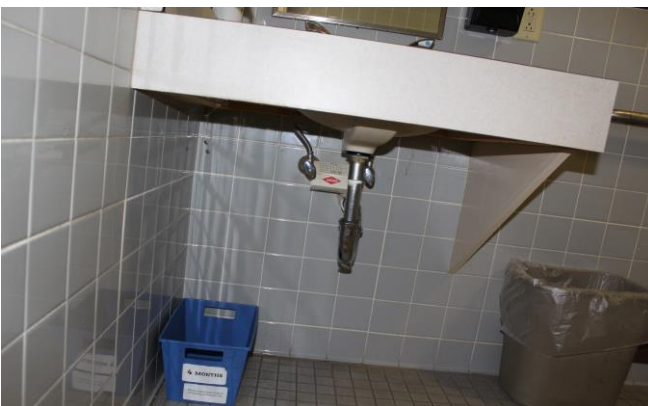
The bathrooms are compliant except for exposed pipes in the men's room.

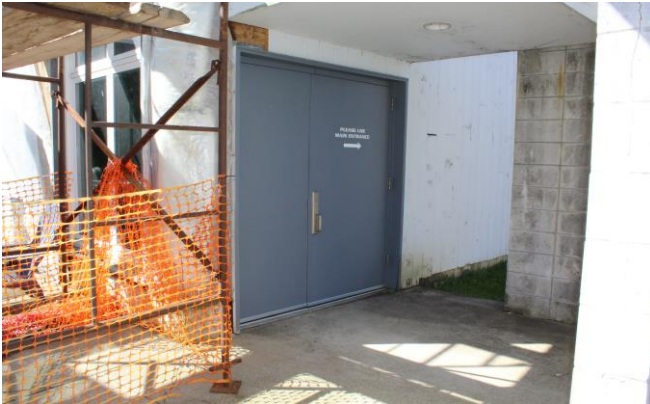
The accessible door is currently blocked because of construction.

The ramp is properly sloped and follows the handrail requirements. The ramp leads to two doors, one of which requires a step into the building and the other is accessible. There are no signs directing someone to the accessible entrance as required by 216.6.

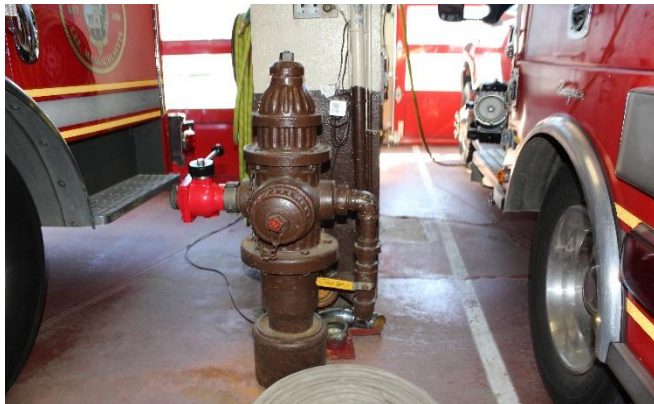
There is not much space for maneuvering.

Once someone enters the building, there is limited space to maneuver because of the size of the fire trucks, which narrow travel routes (305.3) and contain protruding objects (307.2). If the trucks are located elsewhere, there is adequate space.

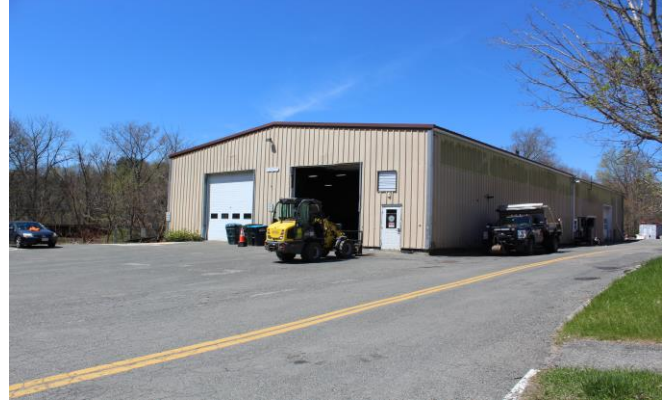
There is a flat and paved surface connecting the parking lot to the building. The garage has large doors that can be opened to make reasonable accommodation. Next to the garage door, there is a smaller pedestrian entrance but there is a change in level, which is not aligned with 303.2.

The DPW garage is accessible.

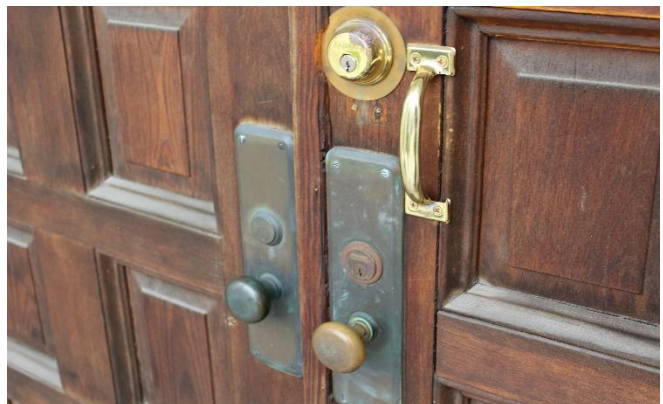
The town previously added a compliant handle to the front door to increase accessibility.

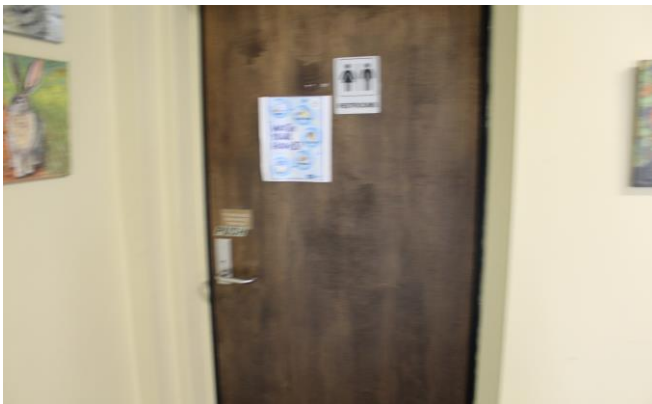
The bathrooms are not appropriately signed.

The signs also need to be located on the latch side of the door as specified in 703.4.2.

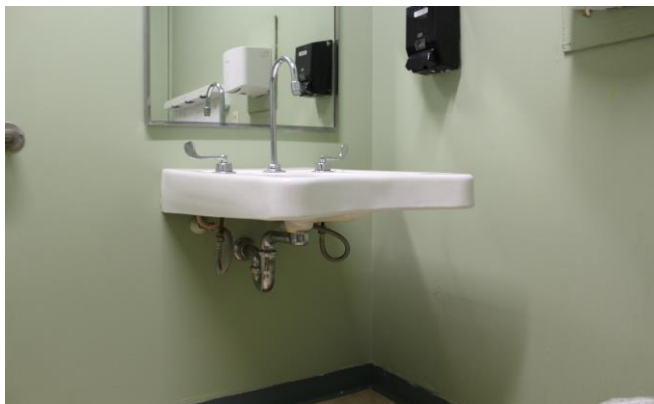
There are exposed pipes that should be covered.

The doors to the bathroom are too heavy, requiring patrons to utilize approximately 9 lbs. of pressure to open, which is above standards established in 404.2.9.

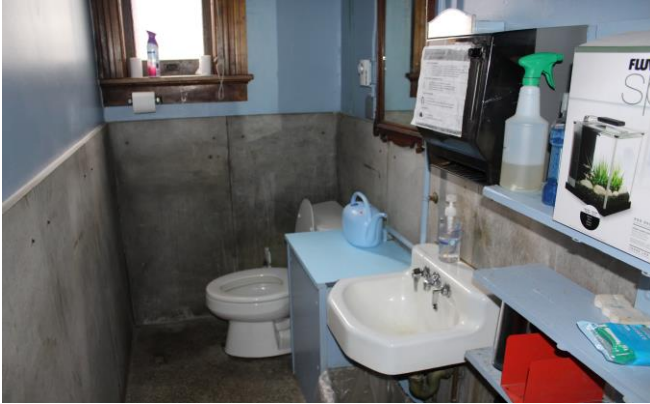
The staff bathroom is too narrow to comply with ADA standards.

There is sufficient space, approximately 12 inches, from the pipes to the edge of the sink. However, the water supply and drainpipes are exposed, which is not in conformity with 606.5.

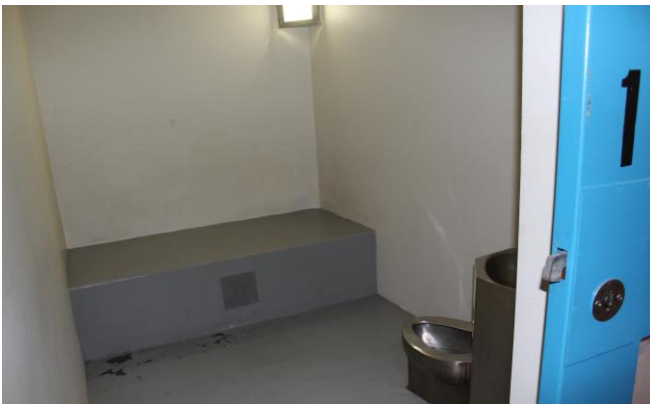
The holding cells comply with ADA standards.

The hallway to the booking room and holding cells has cracks, which can trip up someone with limited mobility or difficult seeing. The ADA standards require floors to be firm and slip-resistant and that there are no changes in level beyond 1/4 of an inch. At the end of a hallway currently used to house custodian equipment, there are broken tiles to the exit, creating a difficult transition.

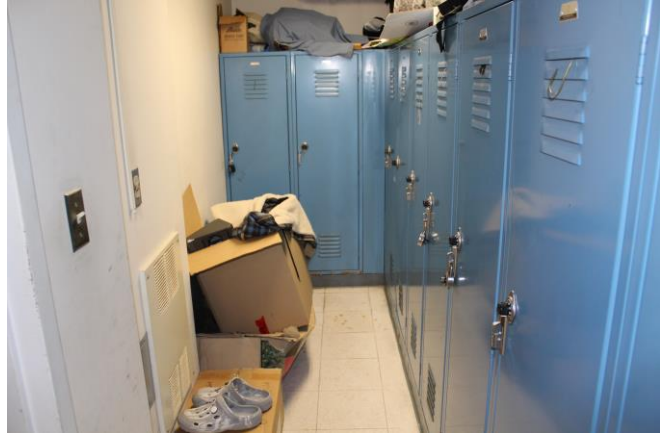
The locker rooms are narrow, but anyone authorized to access them must comply with physical standards to become a police officer.

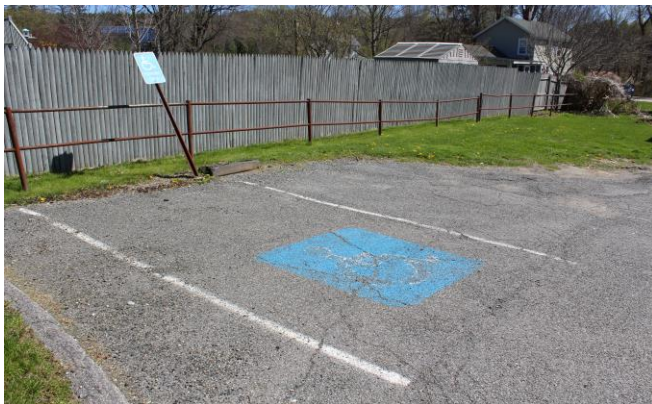
The paint in the current spot is faded and needs repainting. The sign is no longer upright and is at the required height defined in 502.6.

The paint and signage for the accessible parking is faded. There is also sufficient space to turn the spot to be van accessible.

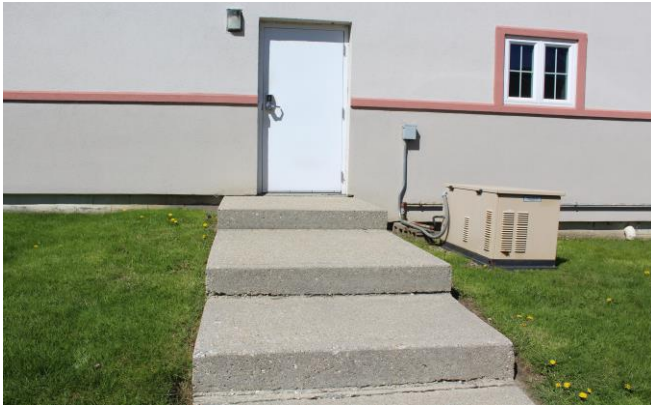
The building has three additional entrances to the building but none of them provide proper signage indicating where the accessible entrance is located, as directed by 216.6.

There are no signs indicating that there is an accessible entrance on the side of the building.

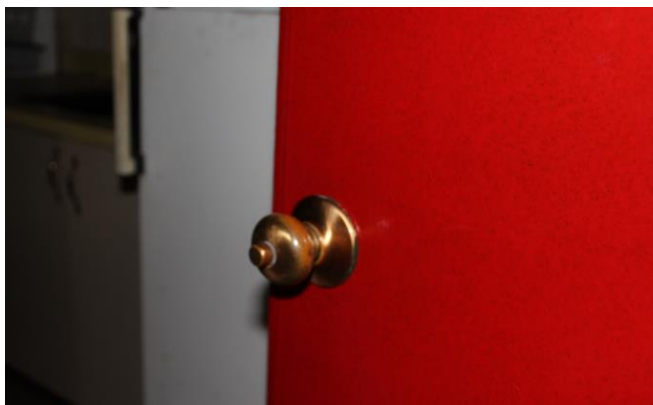
There are exposed pipes under the bathroom sink.

Doorknobs throughout the building limit access from room to room.

The paper towel dispenser is out of reach, measuring approximately 52 inches from the ground, which is above the 48-inch threshold outlined in 308.2.

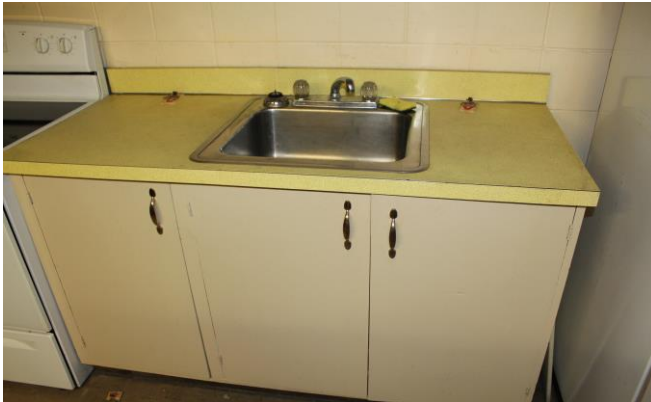
The building also features a utility sink in the garage bay area and a kitchen area. The utility sink is accessible, but the kitchen sink is not accessible because it does not have the proper knee and toe

The sink is not equipped with the appropriate operable parts.

clearances outlined in 306 and the noncompliant handles as outlined in 309.4.

Location	Barrier	Suggested Action	Priority*	Responsibility	Timeframe
Parking	Lines are Fading and Sign Is Falling	Repaint Parking Spot, Reinstall Sign	High	Town of Lee	1-2 Years
	No Van Accessibility	Paint Lines and Install Proper Signage to Signify Van Accessibility Parking			
	No Sign Directing Visitors to the Accessible Entrance	Install Signages at Non-Accessible Entrances Directing Visitors to the Accessible Entrance			
Bathrooms	Multiple Compliance Issues	Renovate Bathrooms	Low	Town of Lee	5+ Years
Kitchen	Non-Compliant Handles on Sink	Install Faucet That Does Not Require One to Grip the Handles	Low	Town of Lee	5+ Years

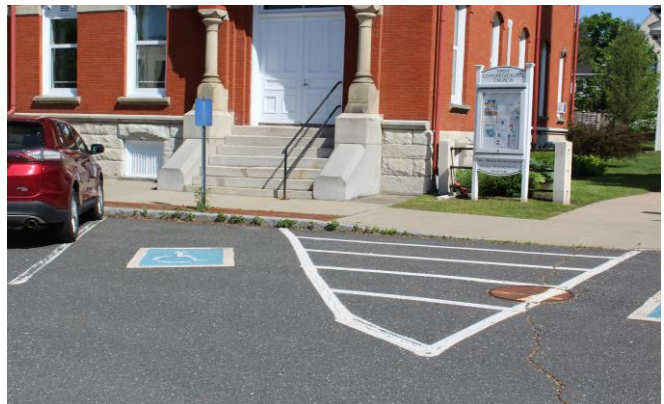
There is a public parking lot serving the town hall and other nearby downtown buildings. The lot has the appropriate number of dedicated accessible parking spaces with van access. The signage for those spaces is below the required 60 inches as specified in 502.6. The signs are also fading and need to be replaced soon.

The spaces are located next to an inaccessible entrance. There is no signage directing people to the accessible entrance as required by 216.6.

There are two accessible parking spaces at Town Hall.

Location	Barrier	Suggested Action	Priority*	Responsibility	Timeframe
Parking	Signage is Fading and Too Low	Replace Signage	High	Town of Lee	1-2 Years
	No Sign Indicating Where Accessible Entrance is Located				
Access	Interior Doors Are Too Heavy	Loosen Door Mechanisms or Replace Doors	High	Town of Lee	1-2 Years
Bathrooms	Exposed Pipes Under Sink	Insulate Exposed Pipes	High	Town of Lee	1-2 Years

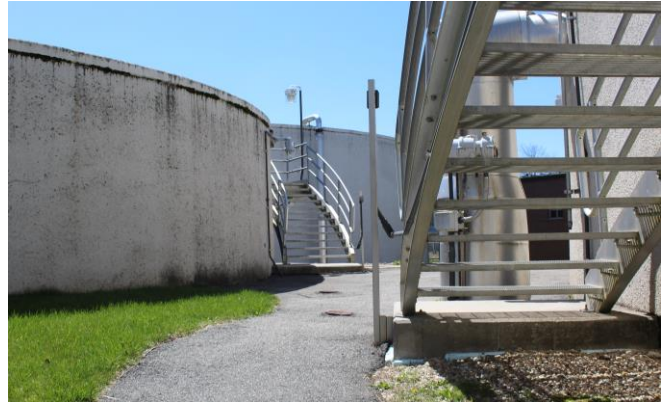
The tanks are not accessible because they require stairs to access but are exempt from the standards under 203.3.

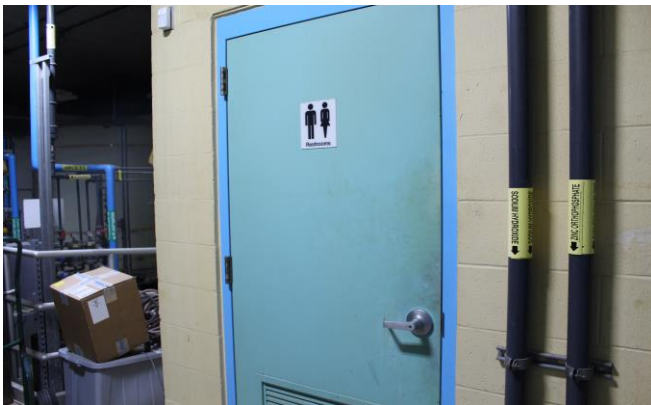
The bathroom does not have appropriate signage.

There are no grab bars, which are not required because of the current use of the building but could be added to increase accessibility.

Location	Barrier	Suggested Action	Priority*	Responsibility	Timeframe
Parking	No Parking	Install Accessible Parking space	Low	Town of Lee	5+ Years
Access	Interior Doors Are Too Heavy	Loosen Door Mechanisms or Replace Doors.	Low	Town of Lee	5+ Years
Restroom	Exposed Pipes under Sink	Insulate Pipes	Low	Town of Lee	5+ Years
	Incorrect Signage	Install new signage

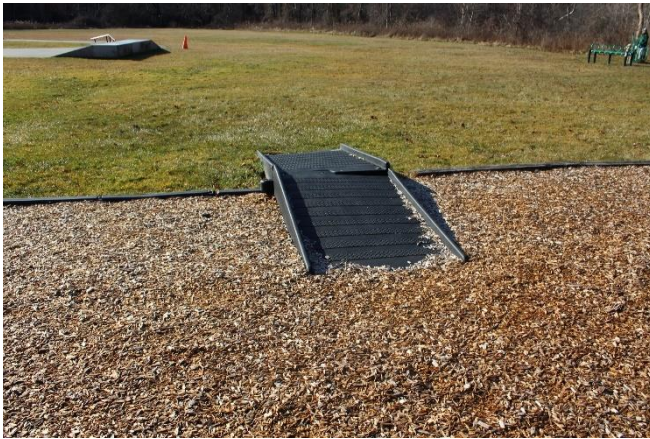
A transition to the playground allows for greater access.

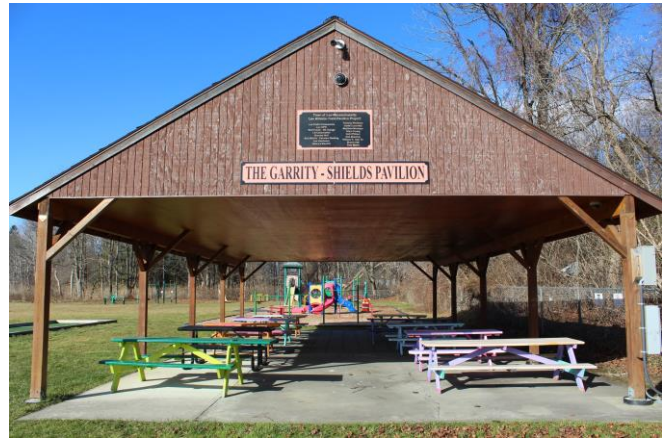
The pavilion features ADA accessible tables.

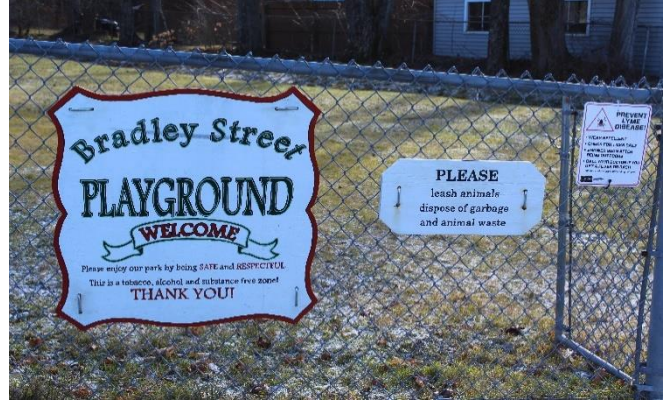
There is no dedicated accessible parking, all parking is on the street and there are no lines delineating spaces. The town should line an accessible space near the entrance to the park and sign it appropriately. A grass transition area is between the entrance gate and the street. Section 208.2 of the 2010 ADA Standards requires all facilities to have at least one accessible parking space.

The Bradley Street Playground is a small neighborhood park.

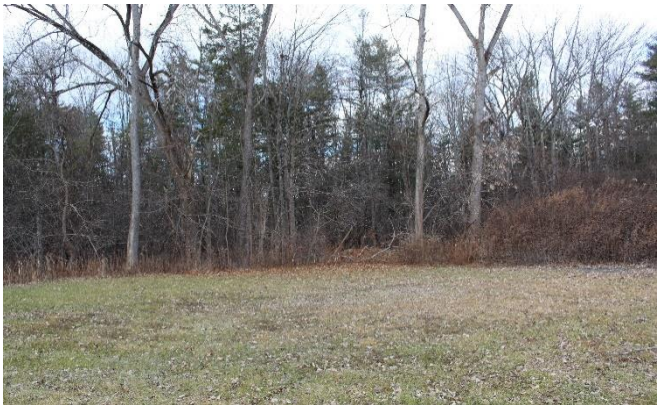
The park has wetland limitations that development of the property.

Dunn Park is not developed.

The town should be thoughtful about any future development and ensure that any additions to the park are ADA compliant and promote inclusion.

Location	Barrier	Suggested Action	Priority*	Responsibility	Timeframe
Undeveloped Land	No ADA Amenities	Ensure Potential Changes to Park Are ADA Compliant	Low	Town of Lee	5+ Years

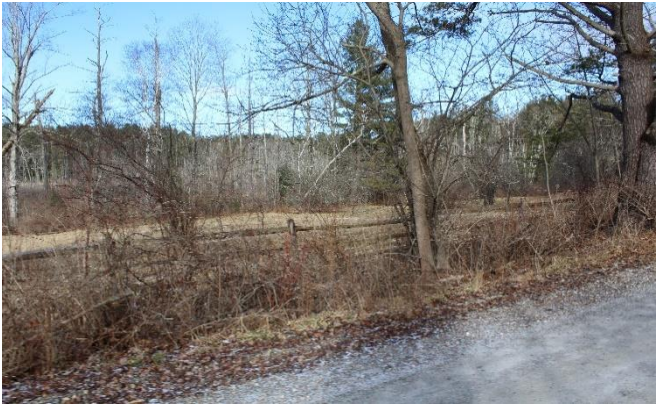
The town has not developed the property.

The town should consider adding d accessible parking near the property and, in the future, consider creating accessible trails throughout to provide people with disabilities with the same access to the space.

Location	Barrier	Suggested Action	Priority*	Responsibility	Timeframe
Undeveloped Conservation Land.	No ADA Accommodations	Add Other Accommodations in Concert with Any Future Development	Low	Conservation Commission	5+ Years

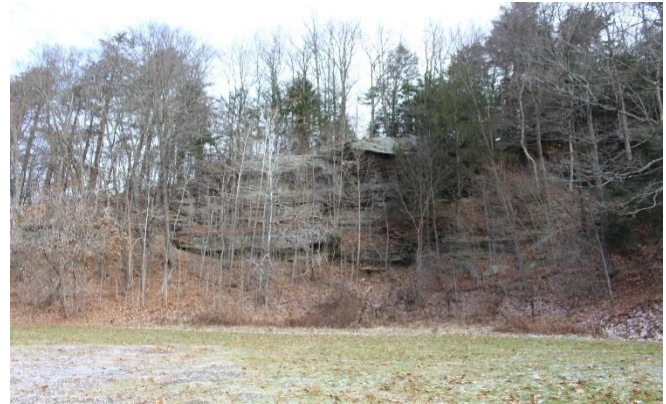
Access to the property is steep and there is no accessible route into the property, which does not comply with 206.2.1. The terrain, however, poses some significant challenges to developing an accessible path that meets accessible slopes.

The property features hiking trails and scenic views.

The trail system is rocky, narrow in places, and does not feature any ADA accommodations.

The town should keep ADA accessibility in mind if it develops the property, including adding ADA compliant benches and tables, creating a path made from firm and slip-proof material, to provide access and developing a trail with appropriate steepness, resting areas, and turnaround spots to allow for greater access for people with disabilities.

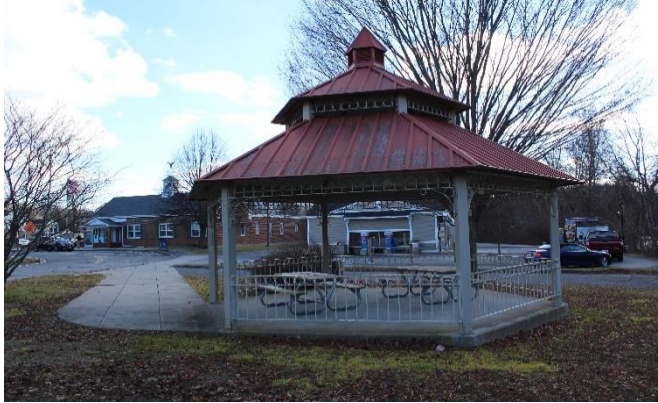
Access to the gazebo is smooth and with an appropriate slope. The benches outside of the gazebo are accessible and located on concrete pads. The tables inside the gazebo are not accessible. The town should install at least one accessible bench inside the gazebo. There is no accessible path to the grill, benches, and trash cans. The town should consider extending the pathway to the gazebo to other elements or place one of each on the existing access path.

The downtown gazebo provides picnic space.

The town should designate a space close to the gazebo for accessible parking and appropriately line and sign it.

Location	Barrier	Suggested Action	Priority*	Responsibility	Timeframe
Access	Grills, Trash Cans, and Benches are Not on the Path.	Move the Grills, Trash Cans, and Benches	High	Town of Lee	In Tandem With New Public Safety Building
Parking	No Accessible Parking	Dedicate Accessible Parking Near the Gazebo	High	Town of Lee	In Tandem With New Public Safety Building

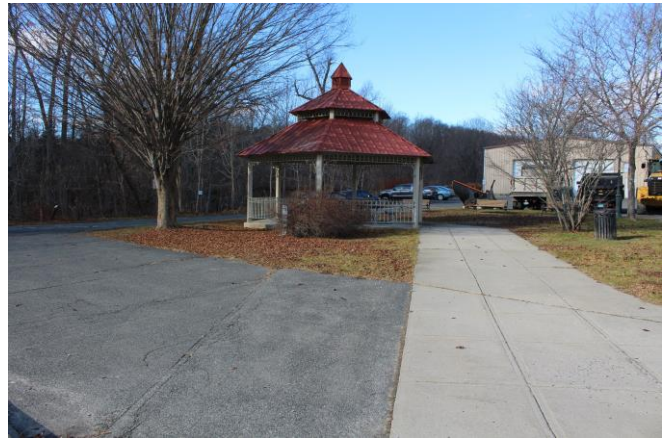
There is an accessible pathway.

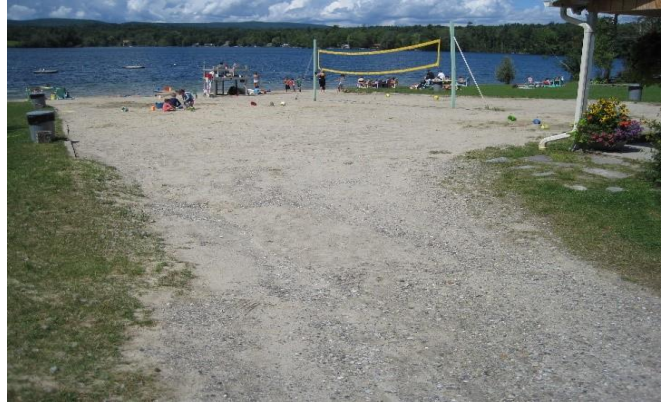
At the beach, there is no accessible path to the water and the picnic tables are not ADA accessible.

The Sandy Beach is privately owned but the public does access it.

Location	Barrier	Suggested Action	Priority*	Responsibility	Timeframe
Access	No Accessible Paths	Install Accessible Path to the Beach.	Low	DPW	5+ Years
		Install Mobi Mat Across the Reach to Reach Water			
Tables	No ADA Picnic Tables	Install ADA Picnic Table	Medium	DPW	3-5 Years

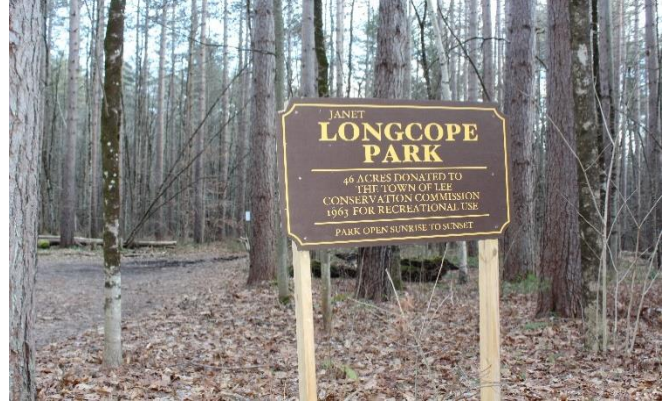
The parking lot is dirt and has no dedicated accessible parking which is not in compliance with 208.2.

The property features a one-mile walking trail for passive recreation, which the town could consider renovating into an accessible trail.

Location	Barrier	Suggested Action	Priority*	Responsibility	Timeframe
Parking	No Accessible Parking	Dedicate Accessible Parking Space	Low	Town of Lee	5+ Years
Access	No Accessible Paths	Install Accessible Path to Trailhead	Low	Town of Lee	5+ Years
Seating	No Available Seating	Add ADA Accessible Bench	Low	Town of Lee	5+ Years

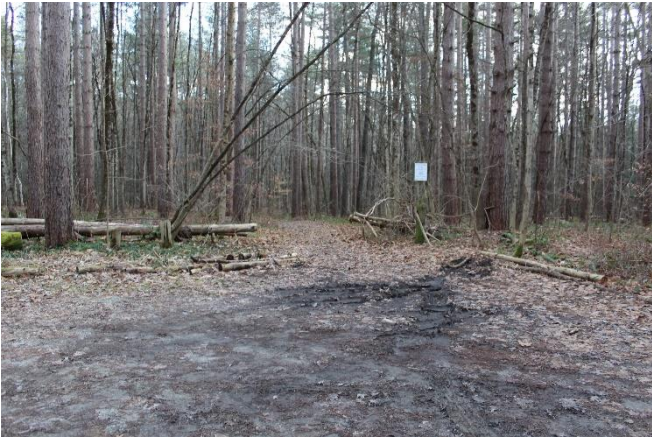
The hiking trail is relatively flat and is a natural surface, which is not slip resistant. There are no additional amenities at the park.

The trail network goes through wet terrain.

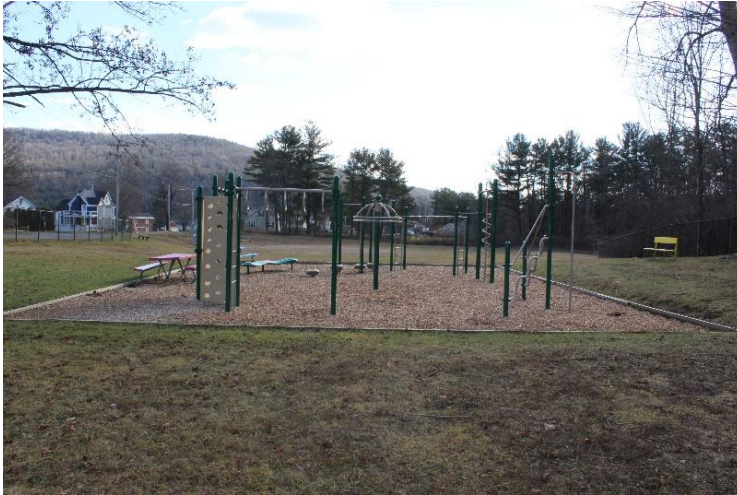
A new playground provides accessibility and safety.

The elements are in good condition, are designed safely, and benches provide adequate accessible resting spots. The playground elements require climbing and there are no ADA accessible swings. The town should consider adding ground-level playground components to ensure people with disabilities are included.

There is no dedicated accessible parking and there is no pathway throughout the park. The town should consider dedicating at least one accessible parking spot and developing an ADA pathway throughout the park.

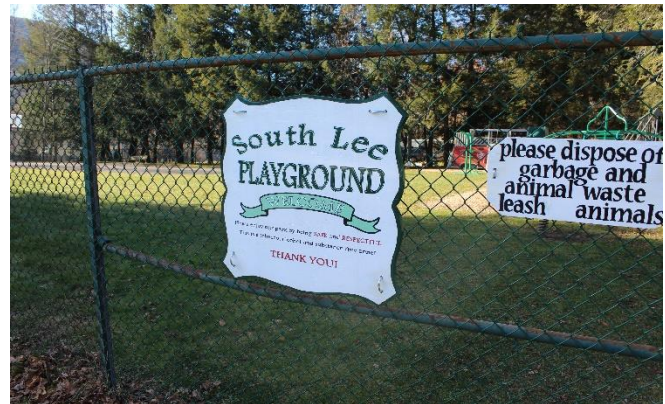
The South Lee Playground is a small neighborhood park.

There is no accessible path through the park.

Location	Barrier	Suggested Action	Priority*	Responsibility	Timeframe
Equipment	Lack of ADA Playground Equipment	Install ADA Equipment	Medium	Town of Lee	3-5 Years
Access	No Accessible Path	Install Accessible Path	Low	Town of Lee	5+ Years

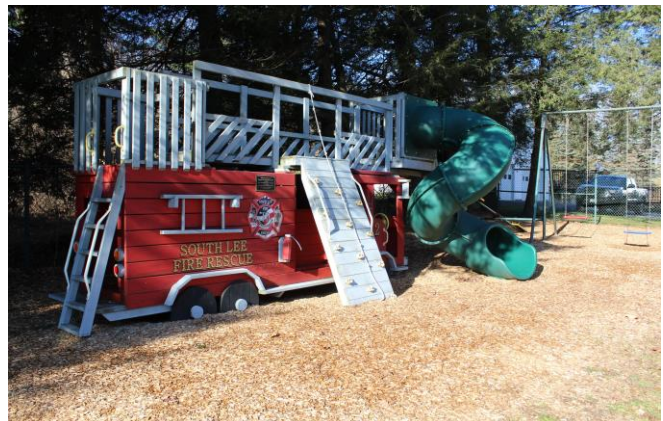
The park features swings and playground equipment.

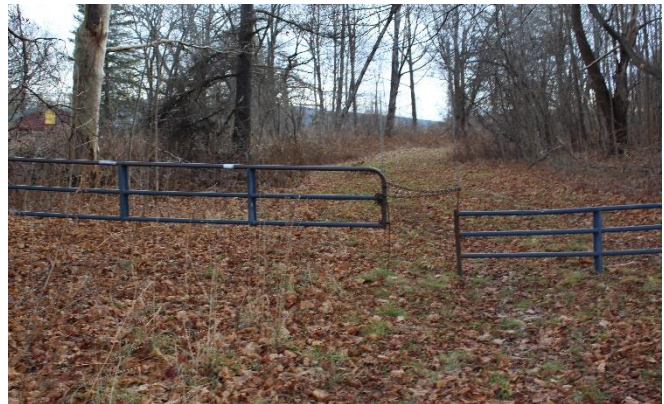
The farm has potential for future recreational use but at this point it is only an open field. The property connects to Longcope Park and the town has the potential to install an ADA accessible trail on the site.

The Town Farm is currently undeveloped.

Location	Barrier	Suggested Action	Priority*	Responsibility	Timeframe
Undeveloped Land.	No ADA Accommodations	Add Accommodations During Development	Low	Town of Lee	5+ Years
Hiking Trails	No ADA trails	Explore Potential To Build ADA Hiking Trail	Low	Town of Lee	5+ Years

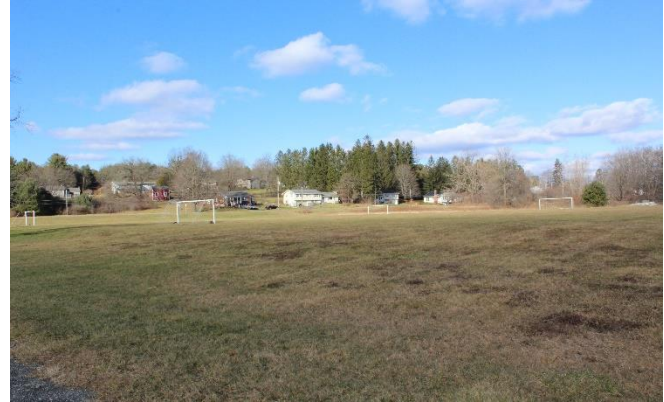
Visitors have parking at the Wastewater Department, however, there is an inadequate number of spots to service both the Wastewater Treatment plant and visitors to the soccer field. Visitors typically park on the grass when attending events or using the fields.

The soccer fields are located along Route 2.

The town should consider adding parking near the fields, separating the spaces for the two property usages, and lessening the distance between the park and the fields. The parking should include at least one accessible space.

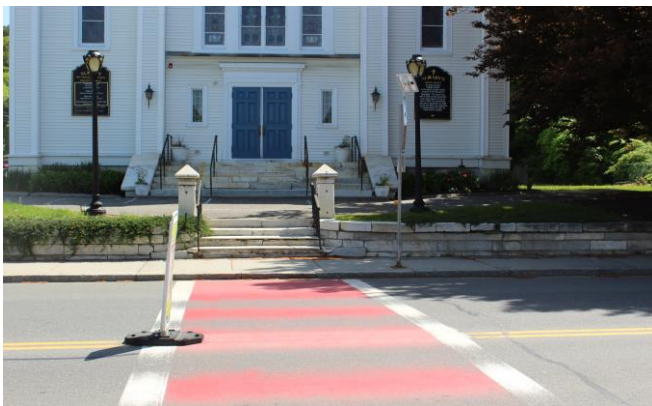
There are some crosswalks on Main Street that do not have curb ramps.

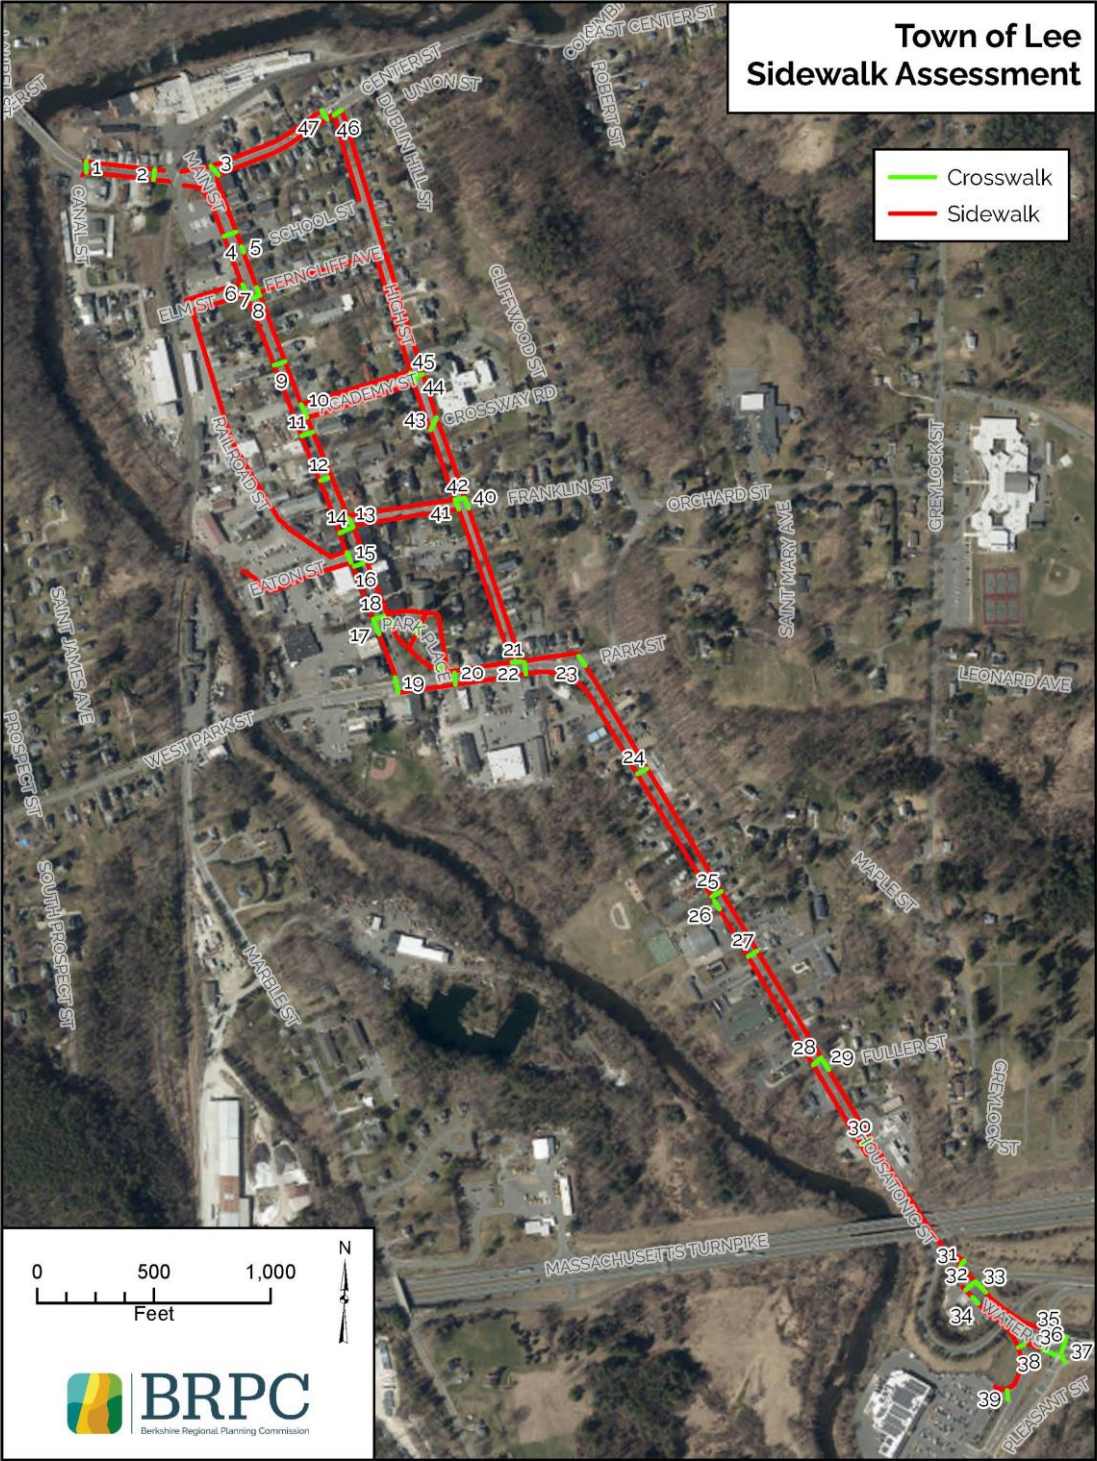
Lee's sidewalks are in generally good condition. High Street is affected significantly by elevation and there are various places where the sidewalks have a cross slope that exceeds the 2% requirement. The intersection with West Center Street also poses a significant increase in elevation that is difficult to address due to the layout of the land.

The typography poses significant challenges in connecting the residential area of High Street with the downtown.
