# ROAD SAFETY AUDIT

## BMC Area Traffic Circulation Improvements

City of Pittsfield

FINAL REPORT April 7, 2016

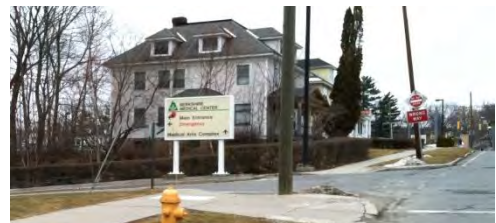
Image 8: Looking north at the BMC Driveway Source: Google Maps

- **Traffic Signs:** There are several regulatory and warning traffic control signs in the vicinity of this intersection. A review of the signage identified a number of issues related to MUTCD standards such as the size of the sign legend, application, and installed location.

- A diamond pedestrian warning sign (W11-2) is mounted at the northwest corner between the BMC driveway and North Street on the same pole as a rectangular “Do Not Enter”

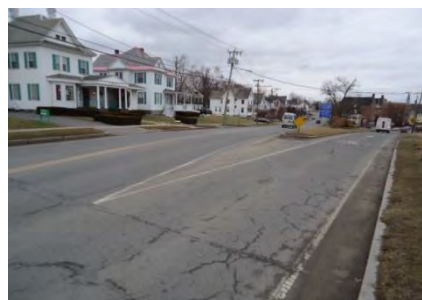
Image 11: Looking southbound on North Street at the diverging lane.

- **Guide Signs:** The First Street/North Street diverge in the southbound direction creates confusion for drivers not familiar with the area. There are no guide signs in that area to help drivers choose the correct lane.

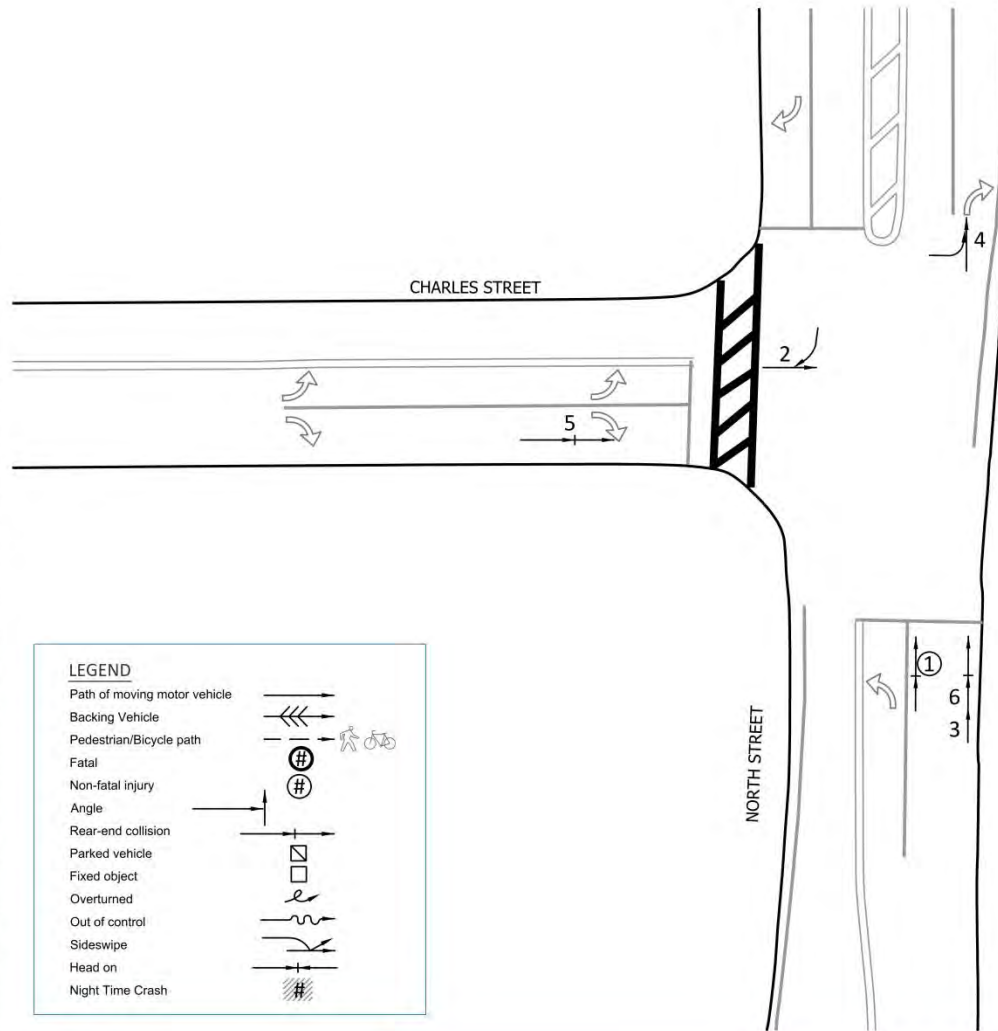
**COLLISION DIAGRAM**

Crash Diagram	Crash Date	Time of Day	Manner of Collision	Light Condition	Weather Condition	Road Surface	Driver Contributing Code	Crash Severity	Ages			Comments
1	8/20/2013	11:45am	Rear-end	Daylight	Clear	Dry	Followed too closely	Non-fatal injury	53	25		Vehicle following too close, rear ended another vehicle
2	2/6/2014	10:36am	Angle	Daylight	Clear	Dry	Unknown	Property damage only	25	32		Opposing turning movements
3	8/13/2014	5:29pm	Rear-end	Daylight	Clear	Dry	Followed too closely	Property damage only	42	54		Three vehicle rear-end accident
4	10/24/2014	5:18pm	Sideswipe (Same dir.)	Dusk	Clear	Dry	Failed to yield right of way	Property damage only	39	59		Vehicle truning onto a major roadway struck another vehicle
5	2/17/2015	6:36am	Rear-end	Daylight	Clear	Ice	No improper driving	Property damage only	38	29		Vehicle slid on ice/snow rear-ending another vehicle
6	8/6/2015	10:54am	Rear-end	Daylight	Clear	Dry	Inattention	Property damage only	27	27	48	Three vehicle rear-end accident

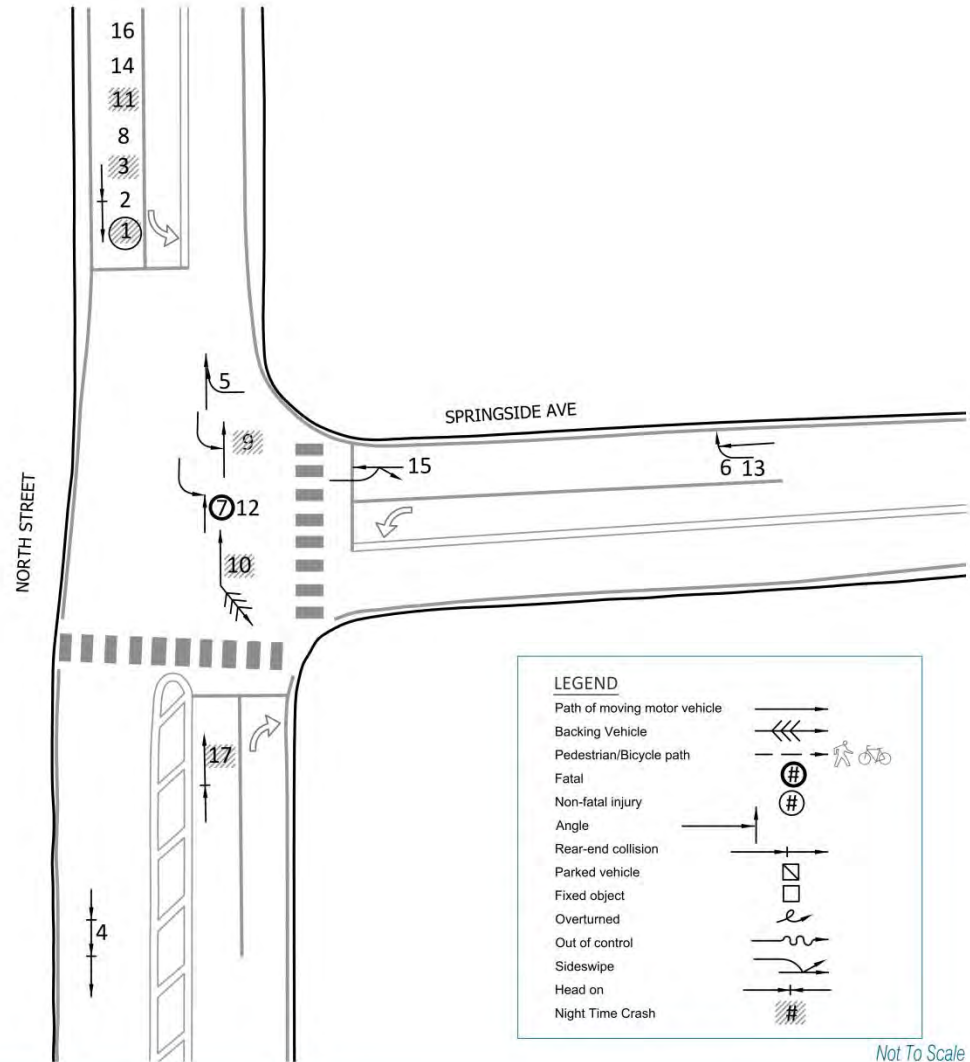
## COLLISION DIAGRAM

INTERSECTION OF NORTH STREET AND SPRINGSIDE AVENUE  
TIME PERIOD ANALYZED: NOVEMBER 1, 2012 TO OCTOBER 31, 2015

Crash Diagram	Crash Date	Time of Day	Manner of Collision	Light Condition	Weather Condition	Road Surface	Driver Contributing Code	Crash Severity	Ages			Comments
1	11/14/2012	6:34pm	Rear-end	Dark-lighted road	Clear	Dry	Inattention	Non-fatal injury	86	67		Vehicle rear-ended another vehicle that was stopped at the intersection.
2	12/11/2012	11:53am	Rear-end	Daylight	Clear	Dry	Followed too closely	Property damage only	43	70		Vehicle rear-ended another vehicle that was slowing down for a red light at the intersection.
3	12/18/2012	10:57pm	Rear-end	Dark-lighted road	Clear	Dry	Exceeded speed limit	Property damage only	21	34		Vehicle rear-ended another vehicle that was stopped at the intersection, then the driver left the scene on foot.
4	1/9/2013	7:08am	Rear-end	Daylight	Clear	Wet	Followed too closely	Property damage only	35	47	62	Three vehicle rear-end accident
5	9/27/2013	7:47am	Angle	Daylight	Clear	Dry	Failed to yield right of way	Property damage only	56	26		Vehicle turning right collided with another vehicle that was stopped to let a pedestrian go

6	1/21/2014	7:02am	Angle	Daylight	Clear	Dry	No improper driving	Property damage only	39	64		Vehicle making a wide right turn into a driveway was struck by another vehicle traveling on the right
7	7/15/2014	12:56pm	Angle	Daylight	Clear	Dry	Failed to yield right of way	Fatal injury	31	50		Vehicle failed to yield to oncoming traffic while turning left and struck a motorcyclist
8	8/12/2014	3:04pm	Rear-end	Daylight	Clear	Dry	Inattention	Property damage only	19	46		Vehicle rear-ended another vehicle that was stopped at the intersection.
9	8/12/2014	8:36pm	Angle	Dark-lighted road	Clear	Dry	Unknown	Non-fatal injury	54	34		Vehicle failed to yield to oncoming traffic while turning left and struck another vehicle
10	8/12/2014	9:08pm	Rear-end	Dark-lighted road	Clear	Dry	Glare	Property damage only	53			Tow truck backed into a police cruiser at an accident scene
11	10/5/2014	12:18pm	Rear-end	Daylight	Clear	Dry	Inattention	Property damage only	18	61		Vehicle rear-ended another vehicle that was stopped at the intersection.

12	12/16/2014	7:39am	Angle	Daylight	Clear	Dry	Inattention	Property damage only	23	23		Vehicle failed to yield to oncoming traffic while turning left and struck another vehicle
13	2/13/2015	3:24pm	Angle	Daylight	Clear	Snow	Other improper action	Property damage only	31	59		Vehicle making a wide right turn into a driveway was struck by another vehicle traveling on the right
14	4/21/2015	8:26am	Rear-end	Daylight	Clear	Dry	Inattention	Property damage only	27	33		Vehicle rear-ended another vehicle that was stopped at the intersection.
15	5/16/2015	9:36am	Sideswipe (Opposite dir.)	Daylight	Cloudy	Dry	Inattention	Property damage only	36	44		Tractor trailer making a tight turn struck a vehicle
16	6/13/2015	5:47pm	Rear-end	Daylight	Clear	Dry	Inattention	Property damage only	24	28		Vehicle rear-ended another vehicle that was slowing down for a red light at the intersection.
17	7/2/2015	10:42pm	Rear-end	Dark-lighted road	Clear	Dry	Inattention	Property damage only	24	45		Vehicle rear-ended another vehicle that was slowing down for a turning vehicle at the intersection.
